Quinquennial Inspection Report

Christ Church
Ballynure and Ballyeaston
Antrim
Connor

December 2019

McCOLLUM CONSERVATION
HISTORIC BUILDING CONSULTANTS | CHARTERED BUILDING SURVEYORS

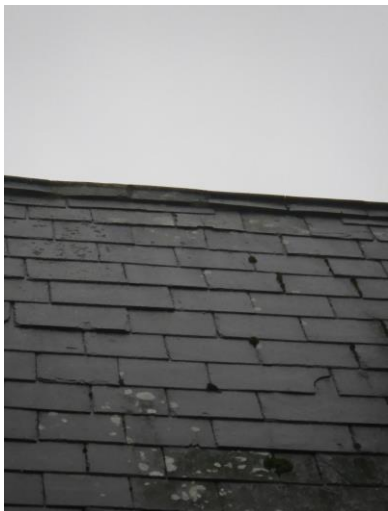
ROOF COVERINGS	<u>Description</u>		
	Pitched roof, overlaid with Welsh slate.		
	<u>Condition</u>		
	Roof slating remains in reasonable condition, with evidence of fixings across slopes. There is a slate missing to the ridge of the Chancel which should be renewed.

<u>Repair</u>		<u>Cat</u>
	Overhaul Chancel roof.		<u>Cost</u>
Chancel roof		A	£150

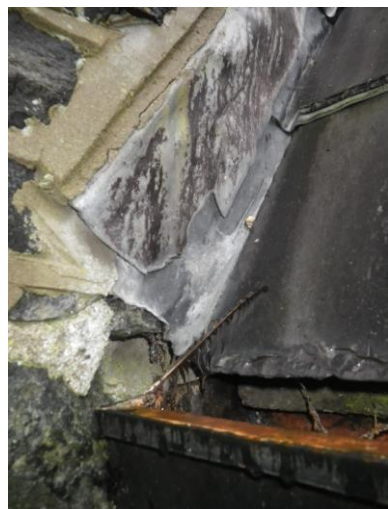
<u>Condition</u> The Vestibule is in a similar condition to the remainder of the Church and leadwork has been overworked with a repair noted during the previous inspection outstanding. Timber doors are in reasonable condition. Slates to the ridge of the Porch are vulnerable to wind uplift and some have already been clipped. The condition of these slates should be kept under review.		
	<u>Repair</u> None suggested in this reporting period.	<u>Cat</u> --	<u>Cost</u> --

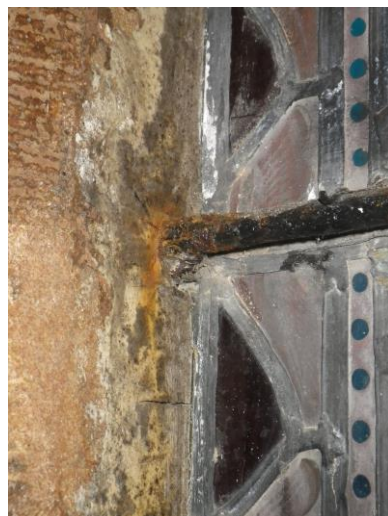
<p>Corrosion of ferramenta</p>	<u>Condition</u> Windows remain sound. However, tracery to the east window is wet due to condensation and the condition of the metal ferramenta should be reviewed periodically. The condensation trap to this window does not have a drain and it might be best to remove it. Finally, some tying in of the ferramenta is required to this window where it has failed.		
	<u>Repair</u> Periodic review of condition of east window, removal of trap and repairs.	<u>Cat</u> M	<u>Cost</u> £550

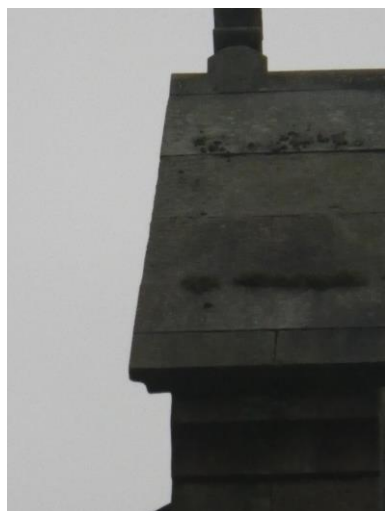
Bellcote canopy

The stone to the Bellcote continues to perform, however, the joints are now open and vegetation is growing. The poor condition of the pointing is allowing driving rain to enter and contribute the saturation of the gable peak internally. This Bellcote requires to be repointed.

Repoint Bellcote.

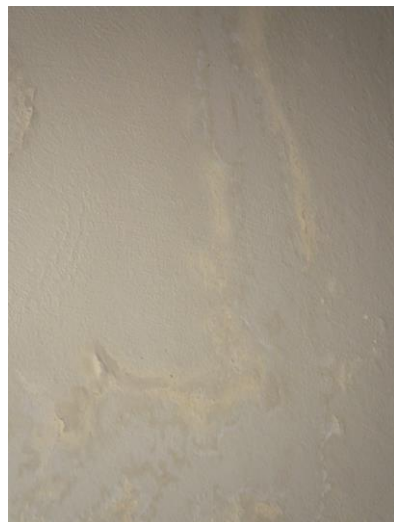
<div>Dampness to west wall</div><div>

<div>Low level dampness</div></div></div>	<div>Description</div> <div>Solid walls with lined and scored painted finish.</div> <div>Condition</div> <div><p>Dampness has become more evident in the Church since the previous inspection, most notably the west wall of the Nave. There is evidence of saturation of the masonry at high level and condensation above the central door. The condition of the Bellcote is contributing to this dampness as is the external pointing style and the detail of the verge stones, all of which will be causing washing of the wall core which further contributes to dampness. The wall requires to be grouted and repointed with the bellcote repointed. Some plaster repairs might prove necessary once the wall has begun to dry.</p><p>A Drymaster is running in the former Bell Pull Room with a de-humidifier in the Vestry. Until work is undertaken to this west wall some thought might be given to extending the de-humidifier to include the main body of the Church. Until all this work is undertaken, there will be flaking paint and plaster to this west wall and periodically the condition of the wall plaster and roof purlin bearing should be reviewed for signs of failure.</p><p>Some low level dampness to main walls is due to blocked gullies and a battered wall foot detail. The dampness is being managed and this should continue.</p></div>

WALLS	<u>Description</u> Rock faced, random rubble basalt with heavy cement strap pointing.		
	<u>Condition</u> There is no evidence of major structural failure to the stonework. However, the strap pointing, as noted at the previous inspection, is both visually obtrusive and is contributing to the dampness experienced internally. This dampness has increased most noticeably to the west gable. Thought should be given to raking out, grouting and deep pointing this gable wall with a breathable, appropriately designed, lime mortar in order to help the wall to dry. Other works to the Bellcote and the verges are noted elsewhere in this report and it would be important that these would be undertaken at the same time. The remainder of the pointing, while inappropriate, has not caused major dampness to the Church and for that reason it is suggested that it remain in place until it begins to fail.		
	<u>Repair</u> Rake out, grout and repoint west gable.	<u>Cat</u> B	<u>Cost</u> £25,000

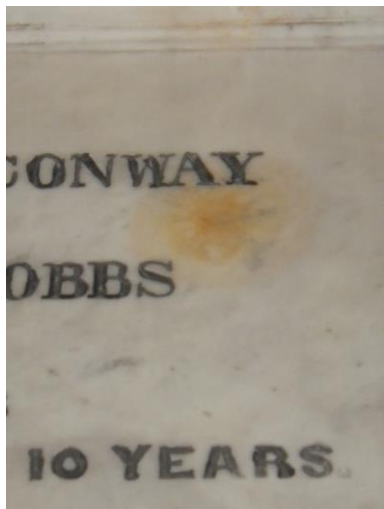
<p>Corrosion of memorial fixing</p>	<u>Description</u> Marble memorials.		
	<u>Condition</u> All memorials appear to be in serviceable condition, except those to the west wall where the corrosion to the fixing has increased since the date of the last inspection. This corrosion is due to the saturation of the wall core as noted earlier in this report. The condition of these memorials should be kept under constant review for as long as the wall is damp, in order to ensure that the fixings do not become loose over the long term. Any evidence of movement whatsoever of these memorials should be taken very seriously and the memorials taken down and re-fixed as part of a larger scheme. The work to deal with the dampness should be initiated when budget permits.		
	<u>Repair</u> Review condition of the Conway memorial periodically.	<u>Cat</u> A	<u>Cost</u> £50
