Quinquennial Inspection Report

The Rectory
11 Church Road, Ballynure
Ballynure and Ballyeaston
Antrim
Connor

October 2021

McCOLLUM CONSERVATION

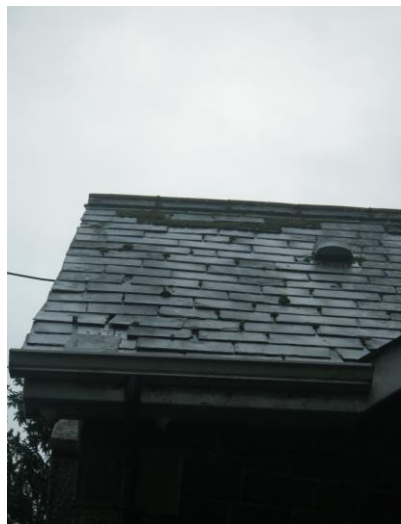
Slipped and dislodged slates to front slopes.

Repairs have been undertaken since the date of the last inspection, but there is evidence of further slipping slates to the pitched roofs. Repairs are necessary in the short term.

Slate repairs

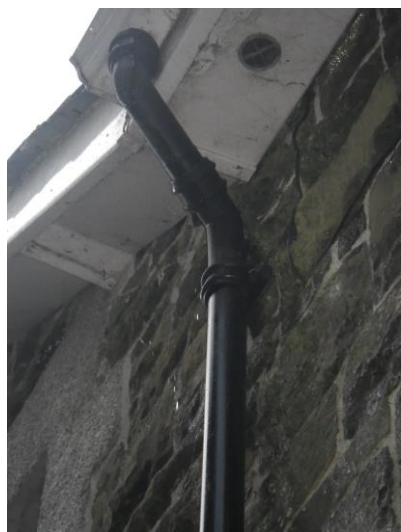
Leaking rainwater goods

Gutters are leaking and repairs are required.

Overhaul gutters

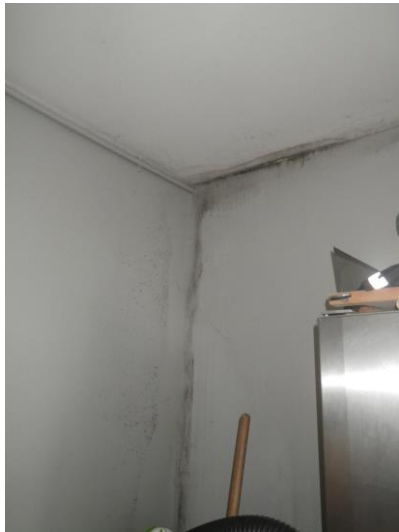
<u>Description</u> Timber stud and solid with plaster and lath and plaster finish.		
	<u>Condition</u> Sound with no evidence of progressive structural failure. It is understood that repairs to the wall liners have been undertaken since the date of the last inspection, including making good of the damp issues noted at that time. There is an issue of condensation to the Utility Room wall at the abutment with the outbuildings. There is dampness due to a cold bridge in the roof and walls which can only be satisfactorily resolved by a scheme of insulation. Until this time the condensation should continue to be managed.		
	<u>Repair</u> None suggested in this reporting period.	<u>Cat</u> --	<u>Cost</u> --
	Condensation to Utility Room
