Quinquennial Inspection Report

St John the Evangelist
Ballynure and Ballyeaston
Antrim
Connor

November 2019

McCOLLUM CONSERVATION

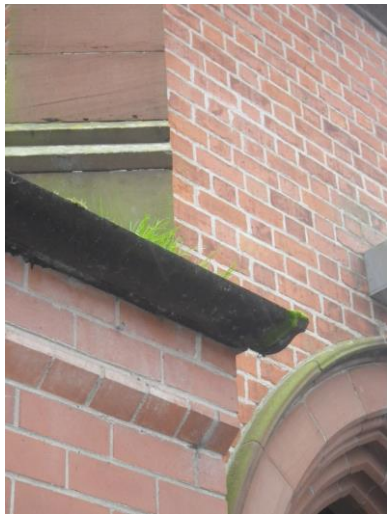
<p>Blocked gutters</p>		
	<u>Condition</u> Gutters are leaking and are full of debris and this is now allowing vegetation to grow to the masonry piers below. Left unattended this will cause masonry to become saturated with the potential for water leaks internally. Gutters should be cleaned, and joints repaired. One downpipe remains repaired with tape and mastic.		
	<u>Repair</u> Overhaul gutters and downpipes.	<u>Cat</u> A	<u>Cost</u> £1,800

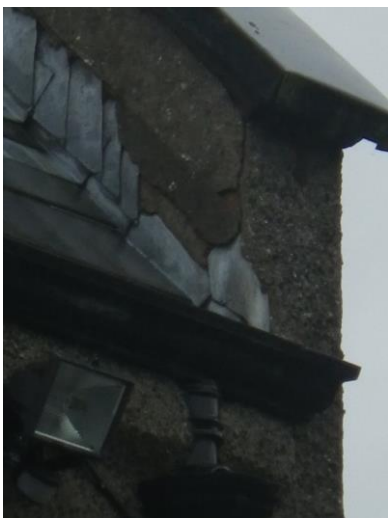
Flashing detail to upstand

<u>Description</u>		
	Stone verge upstands, overlaid with metal cladding.		
	<u>Condition</u>		
	Verges remain sound, however, the cladding to the east verge is now missing and ideally would be re-fitted. Likewise lead soakers and flashings missing to the Chancel roof should be repaired. Render to the Chancel verge continues to perform but as part of a larger scheme, some repairs might be undertaken.		
	<u>Repair</u>	<u>Cat</u>	<u>Cost</u>
	Reset missing lead to Chancel roof and provide cover to verge.	A	£1,200

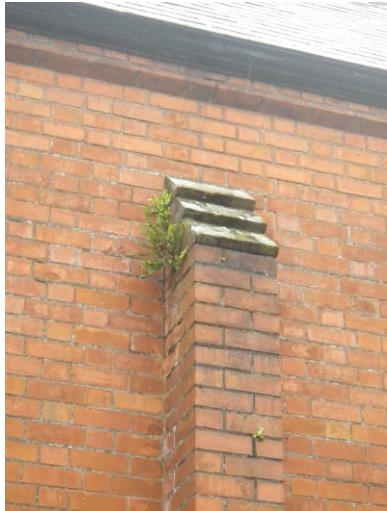
<u>Condition</u> Brickwork and pointing continues to perform and the washing of the walls below the windowsills has not deteriorated further since the date of the last inspection. There is some vegetation growing to piers due to leaking gutters and with the work to the gutters undertaken any vegetation should be sprayed and open joints pointed.		
	<u>Repair</u> Repoint brickwork where required.	<u>Cat</u> C	<u>Cost</u> £ 300

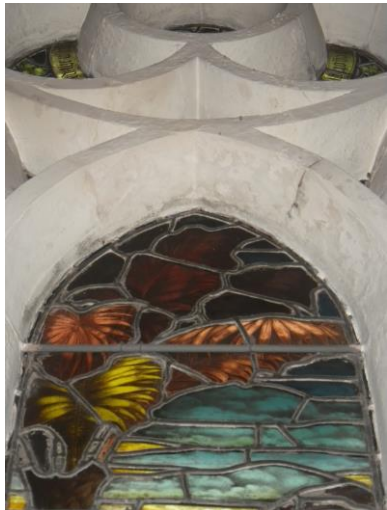
<p>Stained glass window</p>	<u>Description</u> Single lancets filled with coloured and stained glass and with decorative tracery to the east window. Windows fitted with secondary glazing and with individual timber framed lights.		
	<u>Condition</u> Decoration to the windows is now required. Evidence of penetrating damp to the main east window should be arrested if a larger scheme of repair is to be avoided.		
	<u>Repair</u> Redecorate timber framed windows. Point and make good stonework externally to east window.	<u>Cat</u> A A	<u>Cost</u> £ 400 £2,500

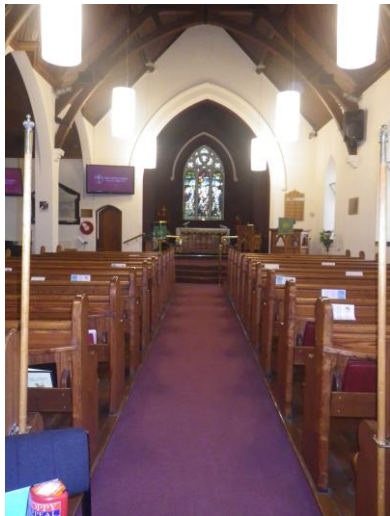
<p>Internal view</p>	<table><tr><td><u>Description</u></td></tr><tr><td>Painted plasterboard and diagonal timber sheeting, set over timber trusses.</td></tr><tr><td><u>Condition</u></td></tr><tr><td>All ceilings appear to be in reasonable condition but with water staining to the south Aisle tapered gutter. It was recorded that work has been undertaken to these tapered gutters with individual gutters being re-aligned.</td></tr><tr><td><table><tr><td><u>Repair</u></td><td><u>Cat</u></td><td><u>Cost</u></td></tr><tr><td>None suggested in this reporting period.</td><td>--</td><td>--</td></tr></table></td></tr></table>	<u>Description</u>	Painted plasterboard and diagonal timber sheeting, set over timber trusses.	<u>Condition</u>	All ceilings appear to be in reasonable condition but with water staining to the south Aisle tapered gutter. It was recorded that work has been undertaken to these tapered gutters with individual gutters being re-aligned.	<table><tr><td><u>Repair</u></td><td><u>Cat</u></td><td><u>Cost</u></td></tr><tr><td>None suggested in this reporting period.</td><td>--</td><td>--</td></tr></table>	<u>Repair</u>	<u>Cat</u>	<u>Cost</u>	None suggested in this reporting period.	--	--

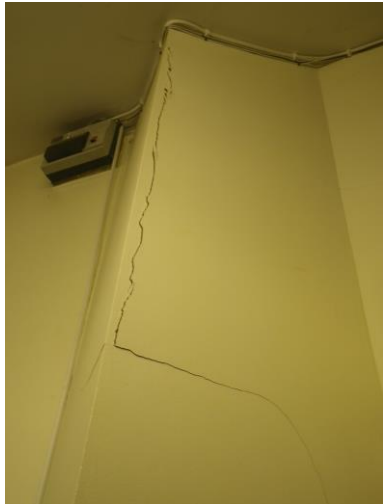
<p>Wall cracking</p>	<u>Description</u> Solid walls, finished with Artex and smooth plaster.		
	<u>Condition</u> Walls all appear to be structurally sound and generally in good condition. The dampness below some windows has not increased much since the date of the last inspection and as repairs are planned externally then the situation should be resolved. Cracking to some wall boxing within the Office should be kept under review but does not appear to be progressive.		
	<u>Repair</u> None suggested in this reporting period.	<u>Cat</u> --	<u>Cost</u> --

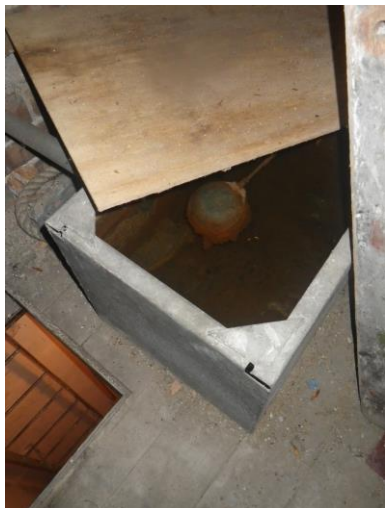
Water tank in Tower

<u>Description</u> Natural gas fired boiler, serving steel panelled radiators.		
	<u>Condition</u> The issue of poor distribution of heating to the south Aisle noted in the previous inspection has now been remedied. The uninsulated and uncovered water storage tank within the Tower remains and if it is redundant. It is recommended that it be drained and disconnected. If the tank is in use it should be covered and insulated.		
	<u>Repair</u> If redundant, drain and disconnect water tank.	<u>Cat</u> A	<u>Cost</u> £ 100

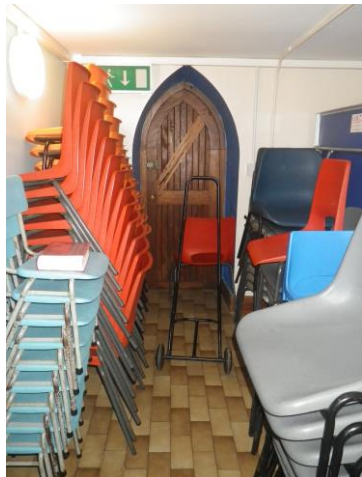
<p>Fire escape blocked and chairs stacked in escape route</p>	<u>Description</u> Fire risk assessment has been prepared.		
	<u>Condition</u> There is good escape signage and lighting within the Church, but some provision of additional extinguishers might be considered. Fire escape blocked as noted earlier.		
	<u>Repair</u> Further fireworks. Unblock fire escape and manage better.	<u>Cat</u> D A	<u>Cost</u> £ 500 £ 200
