**Christ Church  
Ballynure & Ballyeaston  
Antrim  
Connor**

**Quinquennial Inspection Report**

April 2025

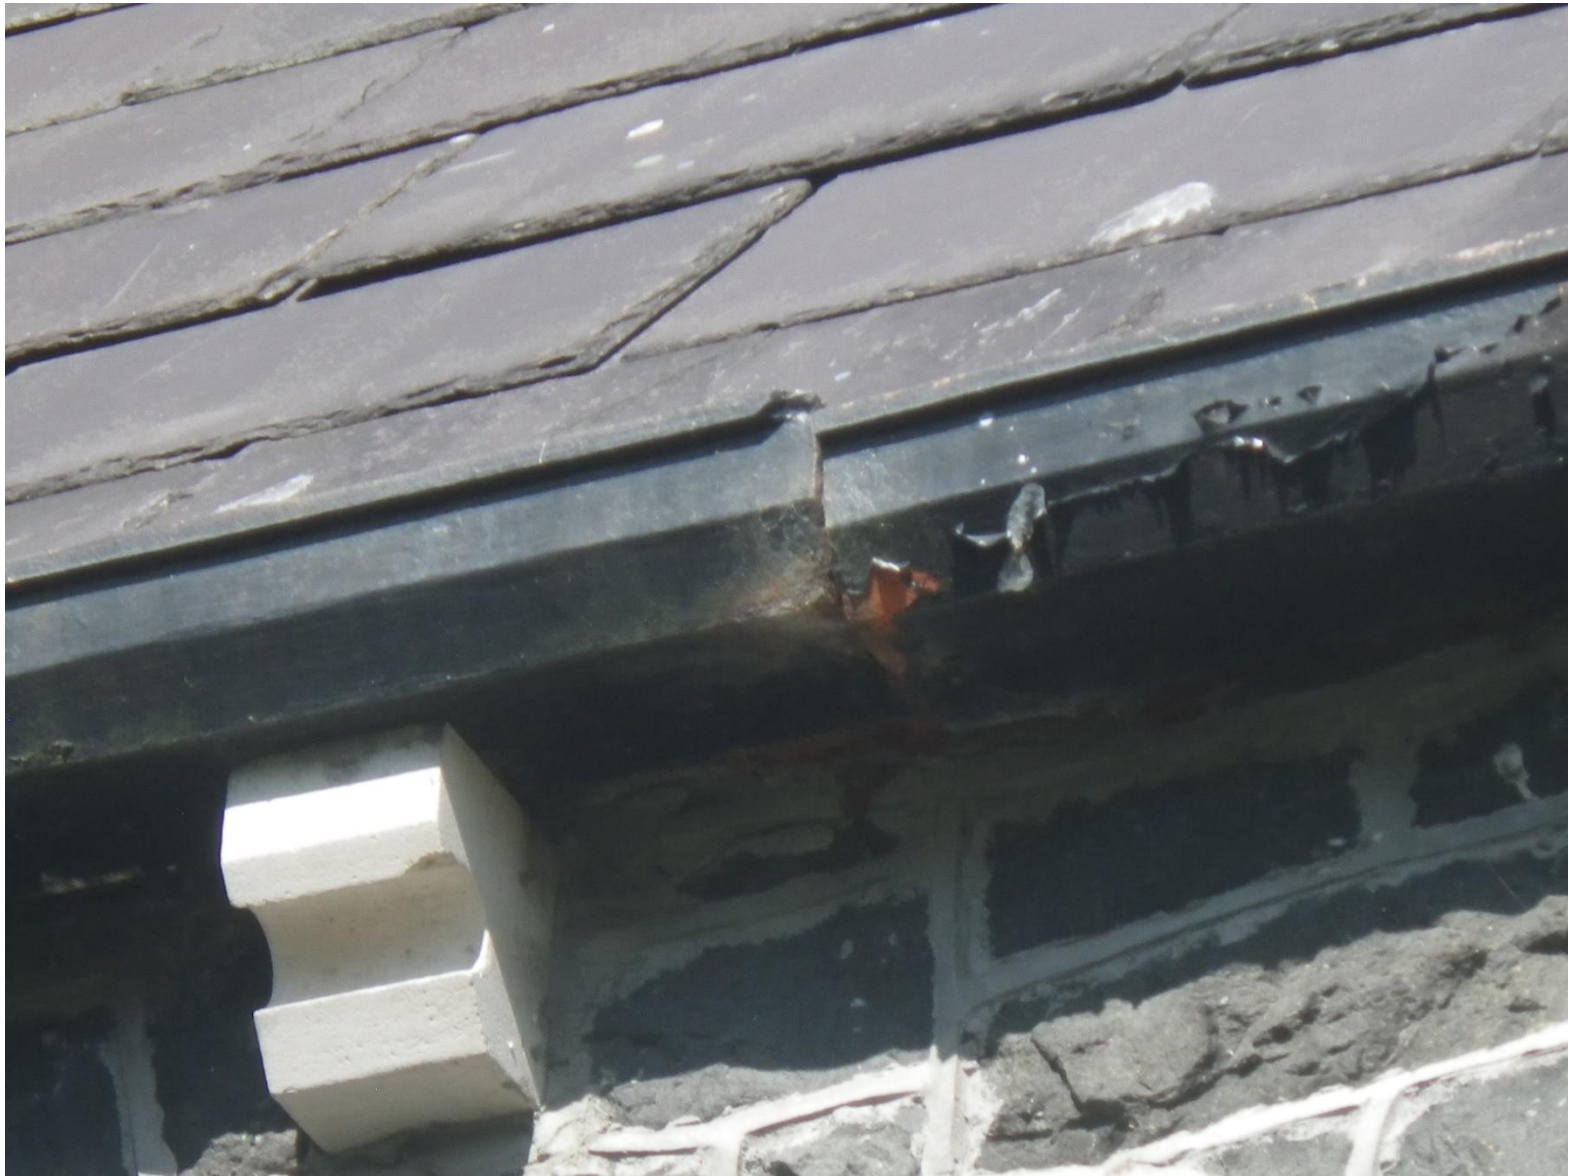
Condition  
Gutters and downpipes are in reasonable condition, but require redecoration to maintain. A broken joint to the Chancel gutter should be remade.

*Broken gutter*

Repair	Cat	Cost
Re-make Chancel gutter.	B	£ 200
Clean down and redecorate all gutters and downpipes.	C	£2,000

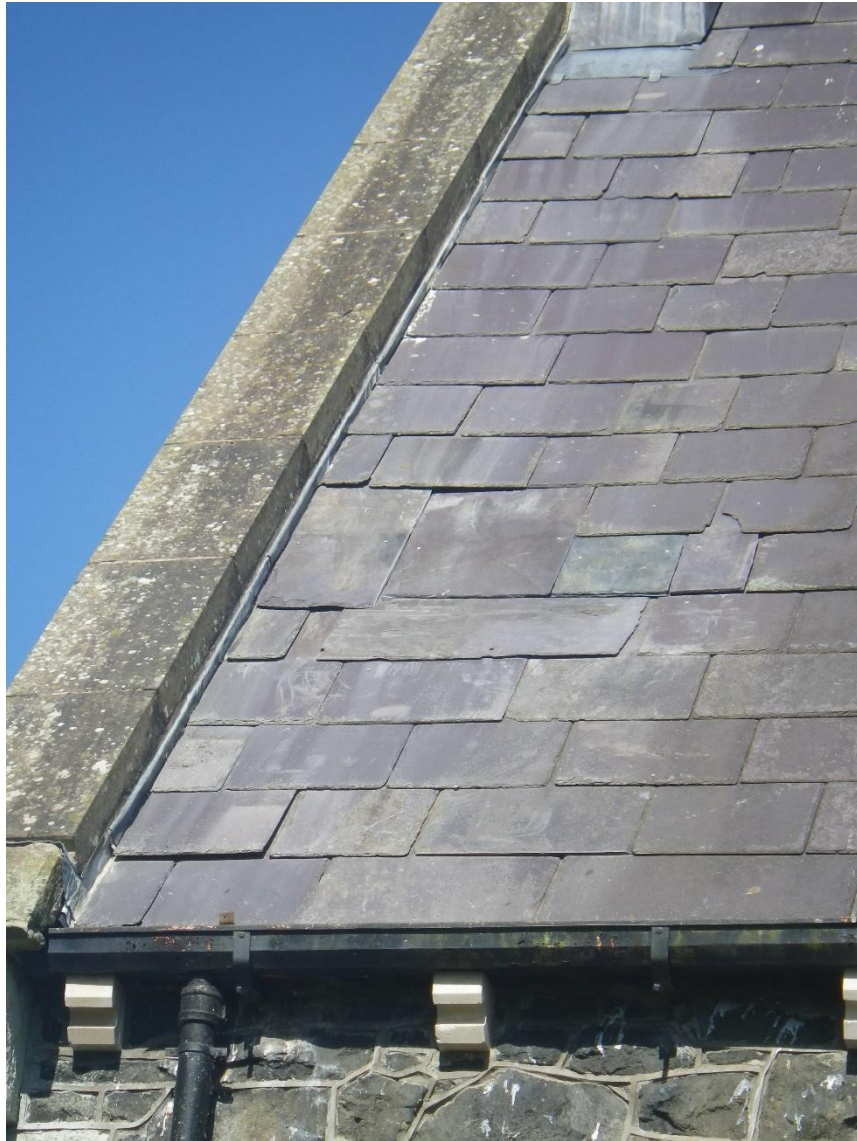
Condition  
Slating on the roof is in reasonable condition and with repairs evident after the recent storms.

***Wind uplift and repairs to Nave roof.***

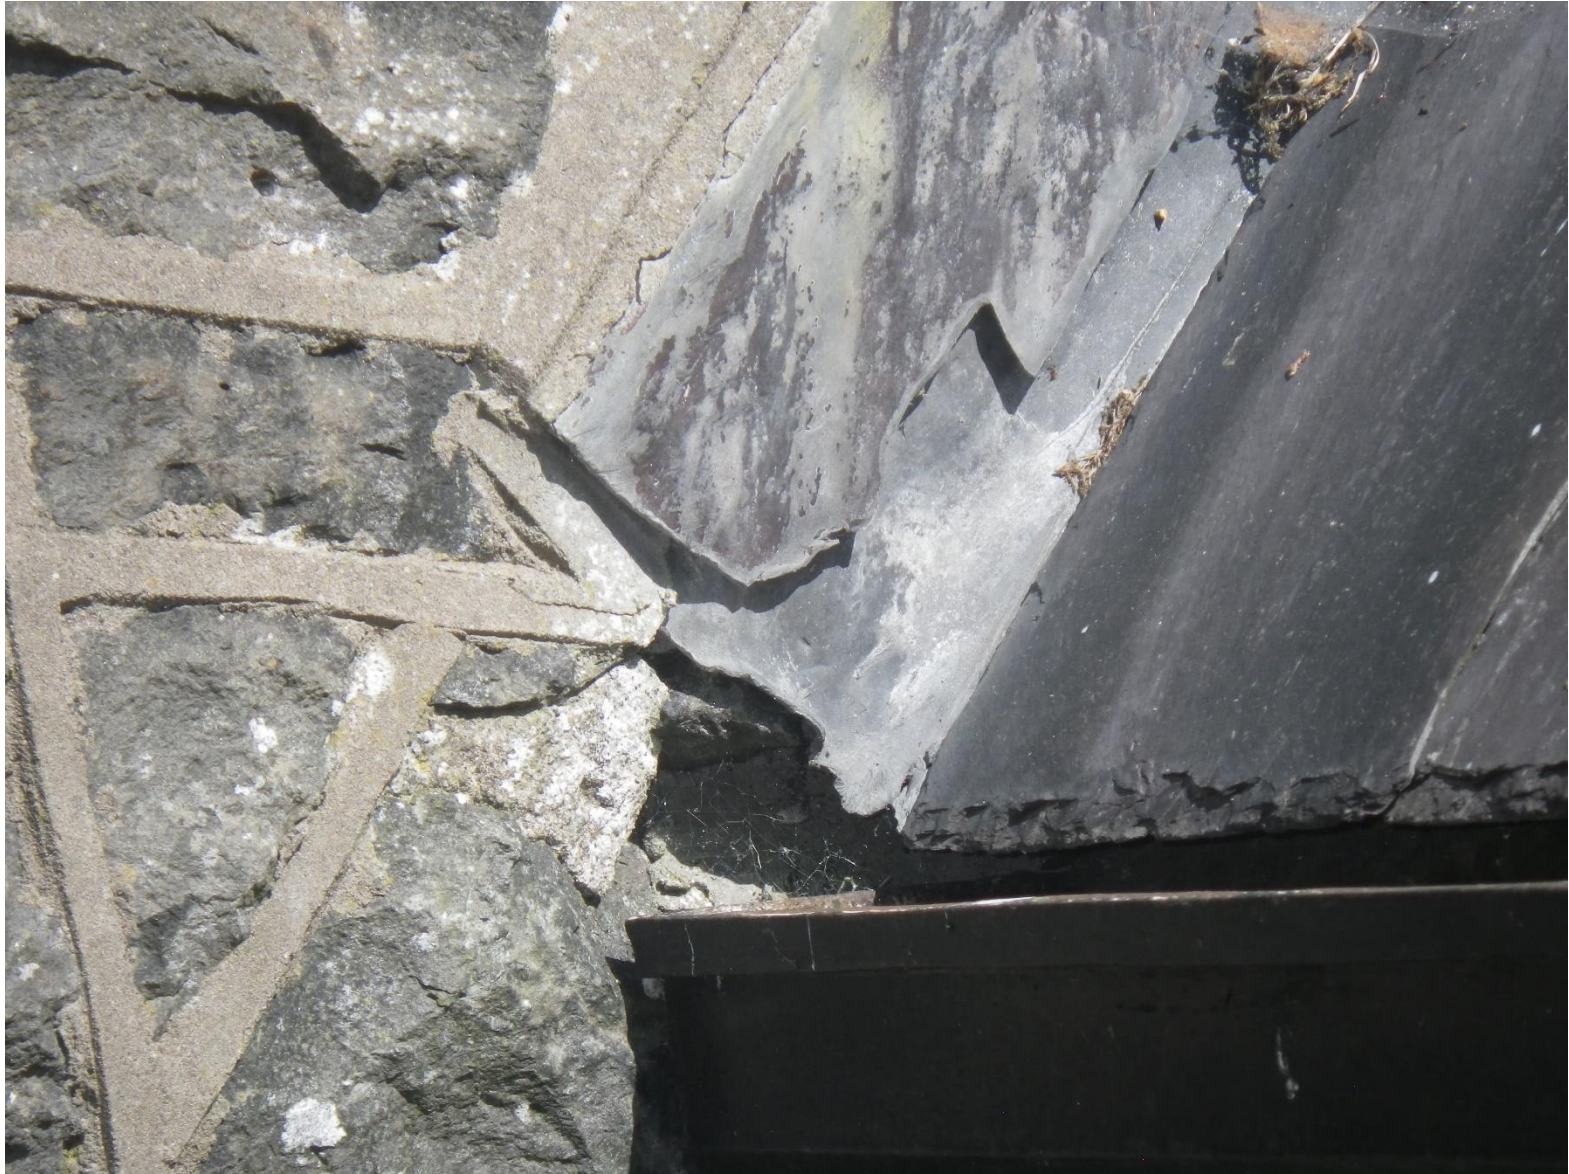
The lead abutment to the roof is cut a little short and would benefit from being re-dressed. Otherwise, the Vestibule is in a similar state to the remainder of the Church.

***Poor lead detail at Porch roof***

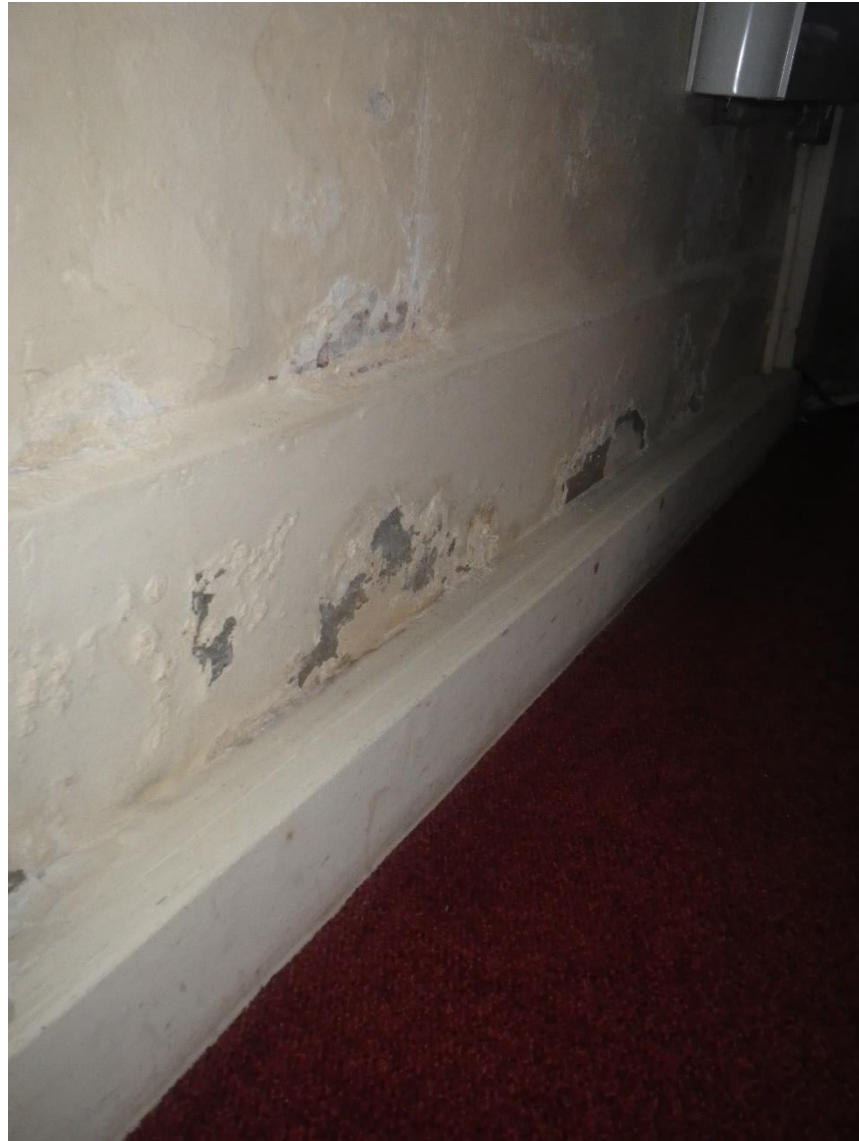
Walls are sound and the patchy dampness noted to the west wall has not increased since the date of the last inspection. There is slight blistering to the west apex which is likely due to the issue with the Bellcote included earlier in this report.

*Dampness in Nave*
