**The Rectory, 11 Church Road, Ballynure  
Ballynure & Ballyeaston  
Antrim  
Connor**

**Quinquennial Inspection Report**

**April 2025**

**McCOLLUM CONSERVATION**

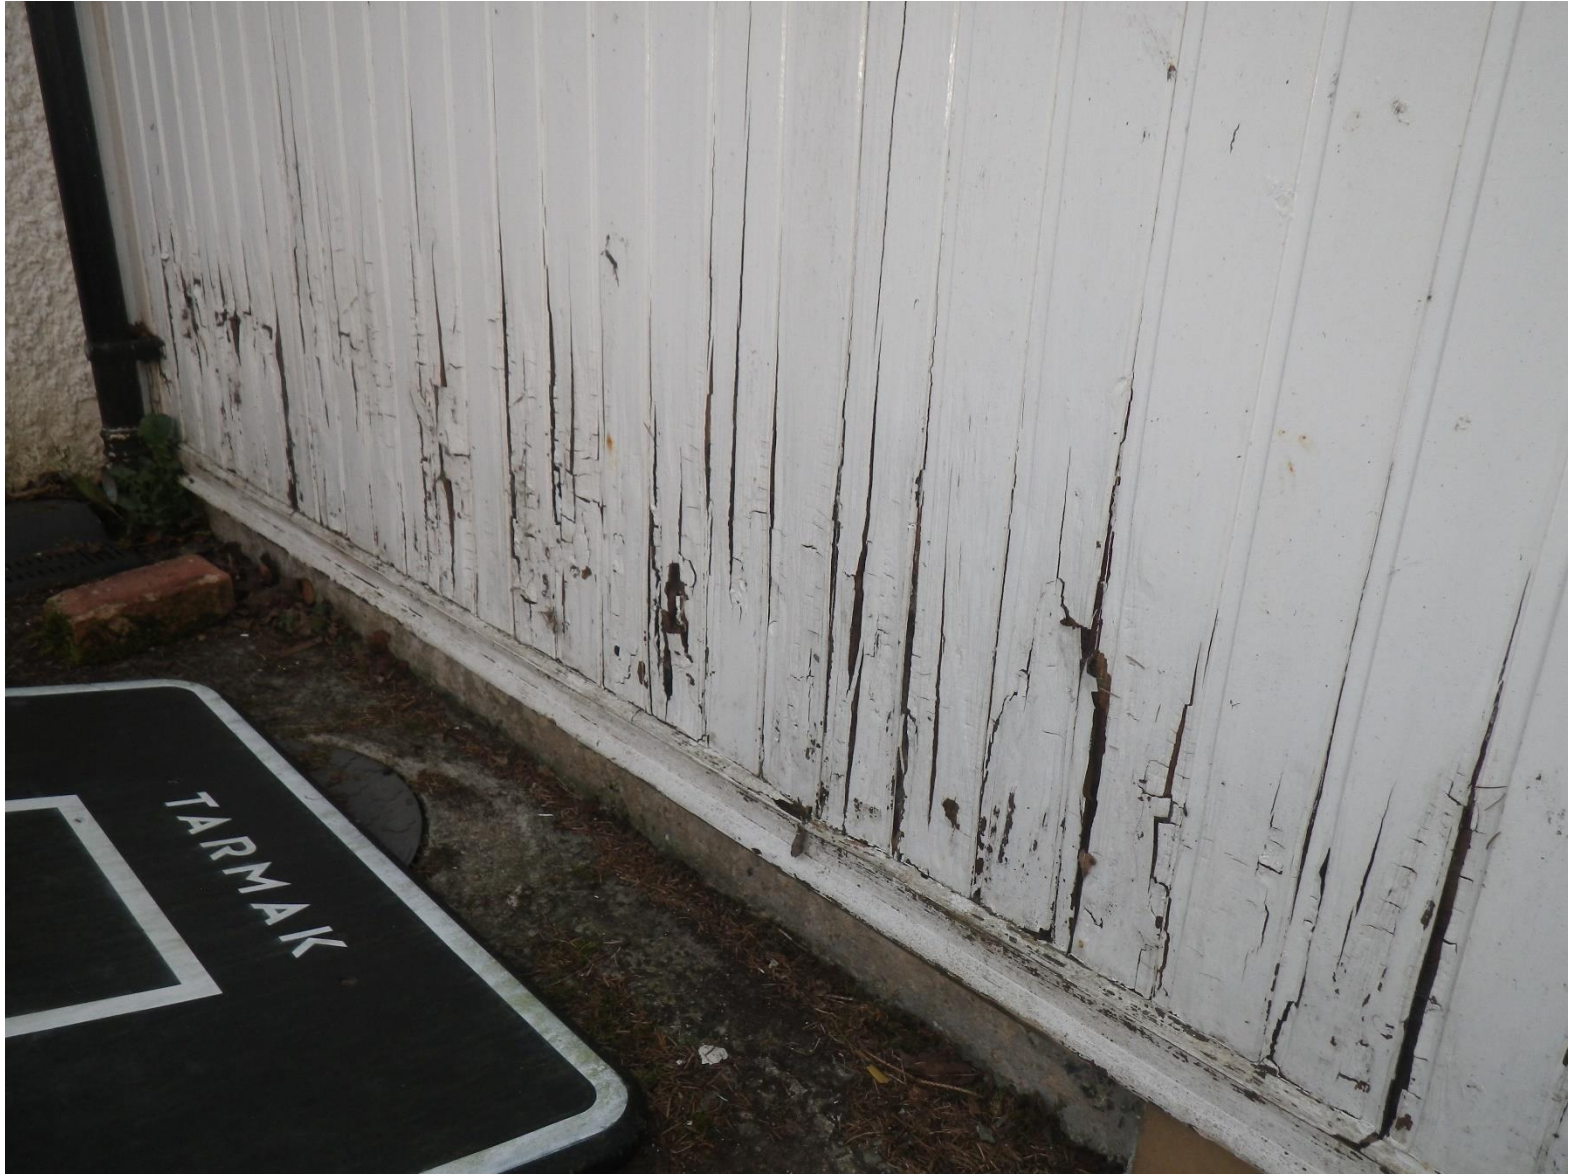
The timber framed walls to the Utility Room have deteriorated significantly since the date of the last inspection and will be renewed as part of the larger scheme planned.

*Timber decay to cladding at Utility Room*

Repair	Cat	Cost
Repairs included with planned refurbishment.	E	To be confirmed.

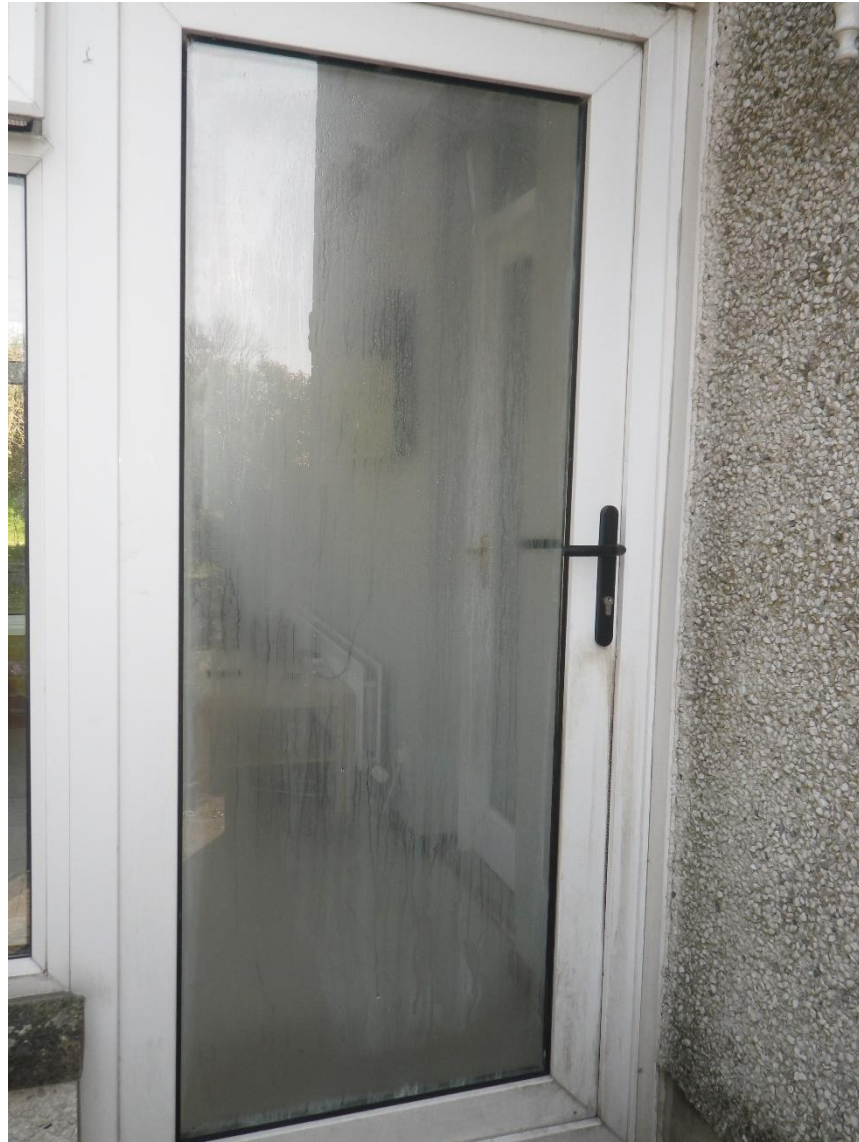
Windows are now beginning to fail and as part of the larger scheme of work some should be renewed.

***Example of extensive condensation to double glazed units***

Repair	Cat	Cost
Phase 1 window renewal.	B	£5,000
Phase 2 window renewal.	C	£7,000

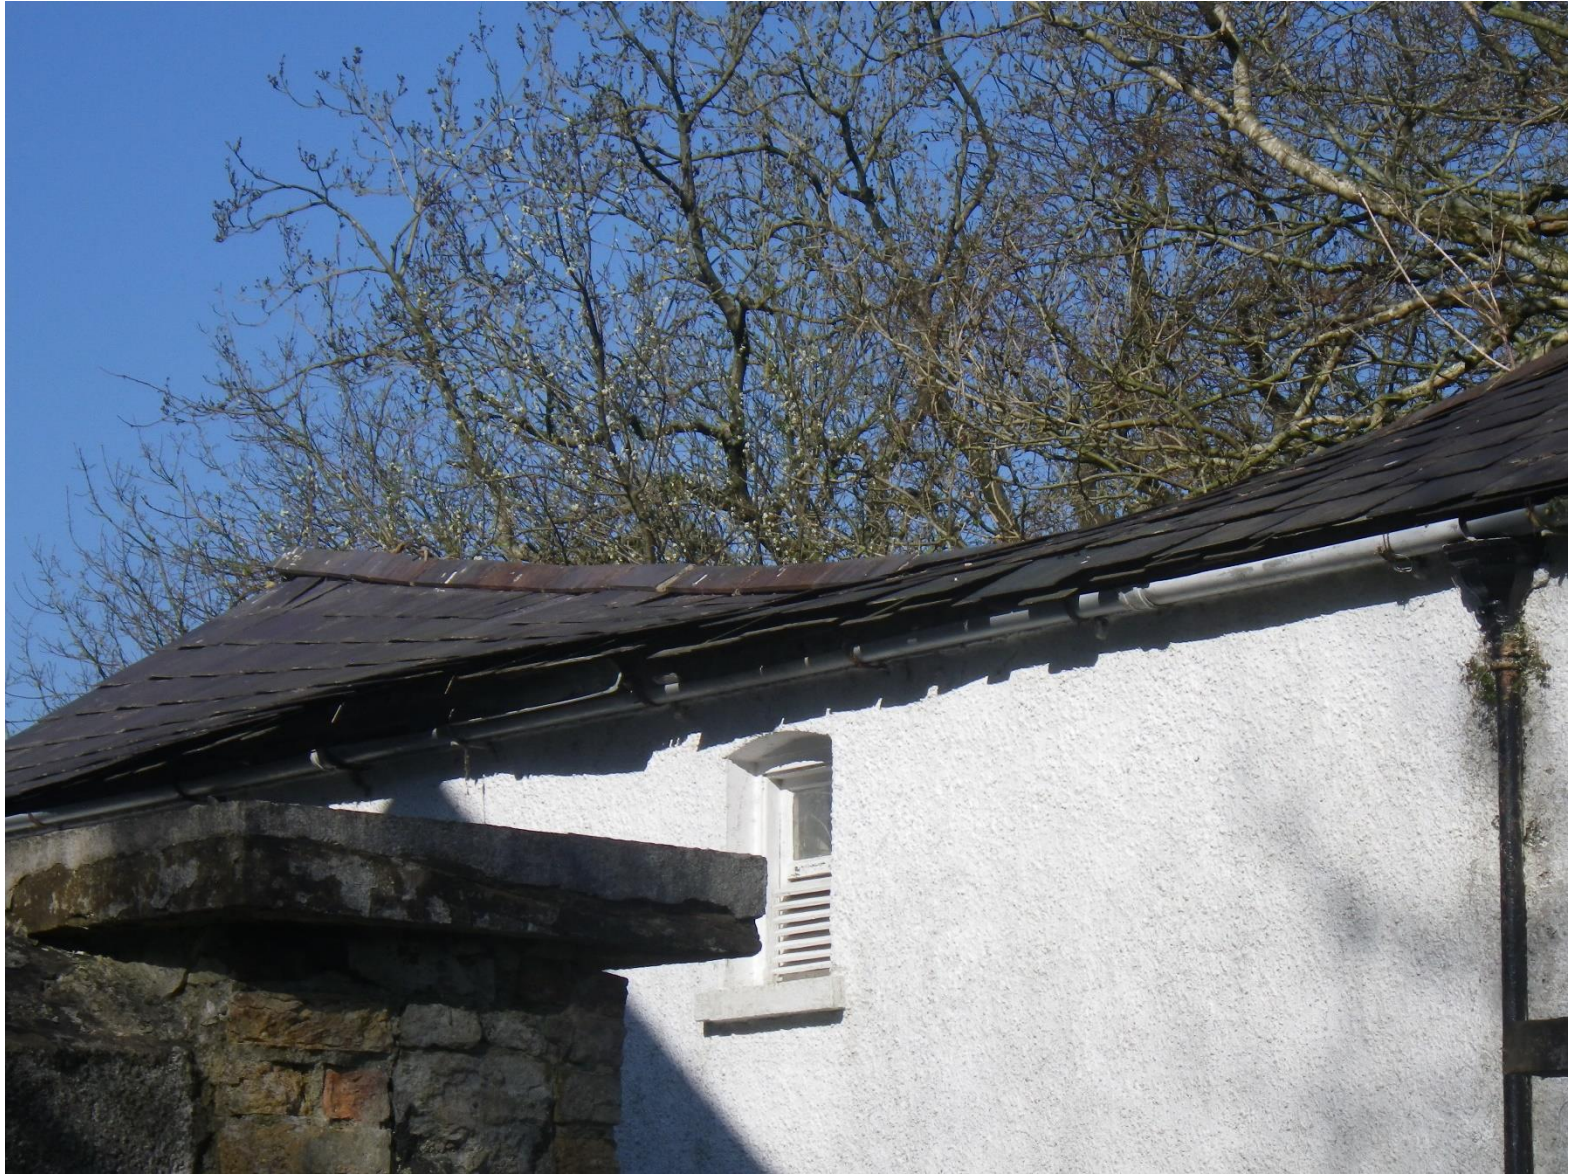
The condition of the outbuilding has deteriorated substantially since the date of the last inspection and the pitched roof is now partially collapsed and in a dangerous state. This roof should be removed immediately and the building made secure and the rear yard cordoned off to prevent access. Without action, this roof is likely to collapse and perhaps then begin to push the wall head leading to further collapse. Despite its poor condition the shed remains in use and this should cease immediately, again for reasons of health and safety.

***Dangerous condition of Outbuilding.***

Repair	Cat	Cost
Cordon off rear yard and make safe outbuilding. Prevent access to the outbuilding and rear yard.	A	£6,000

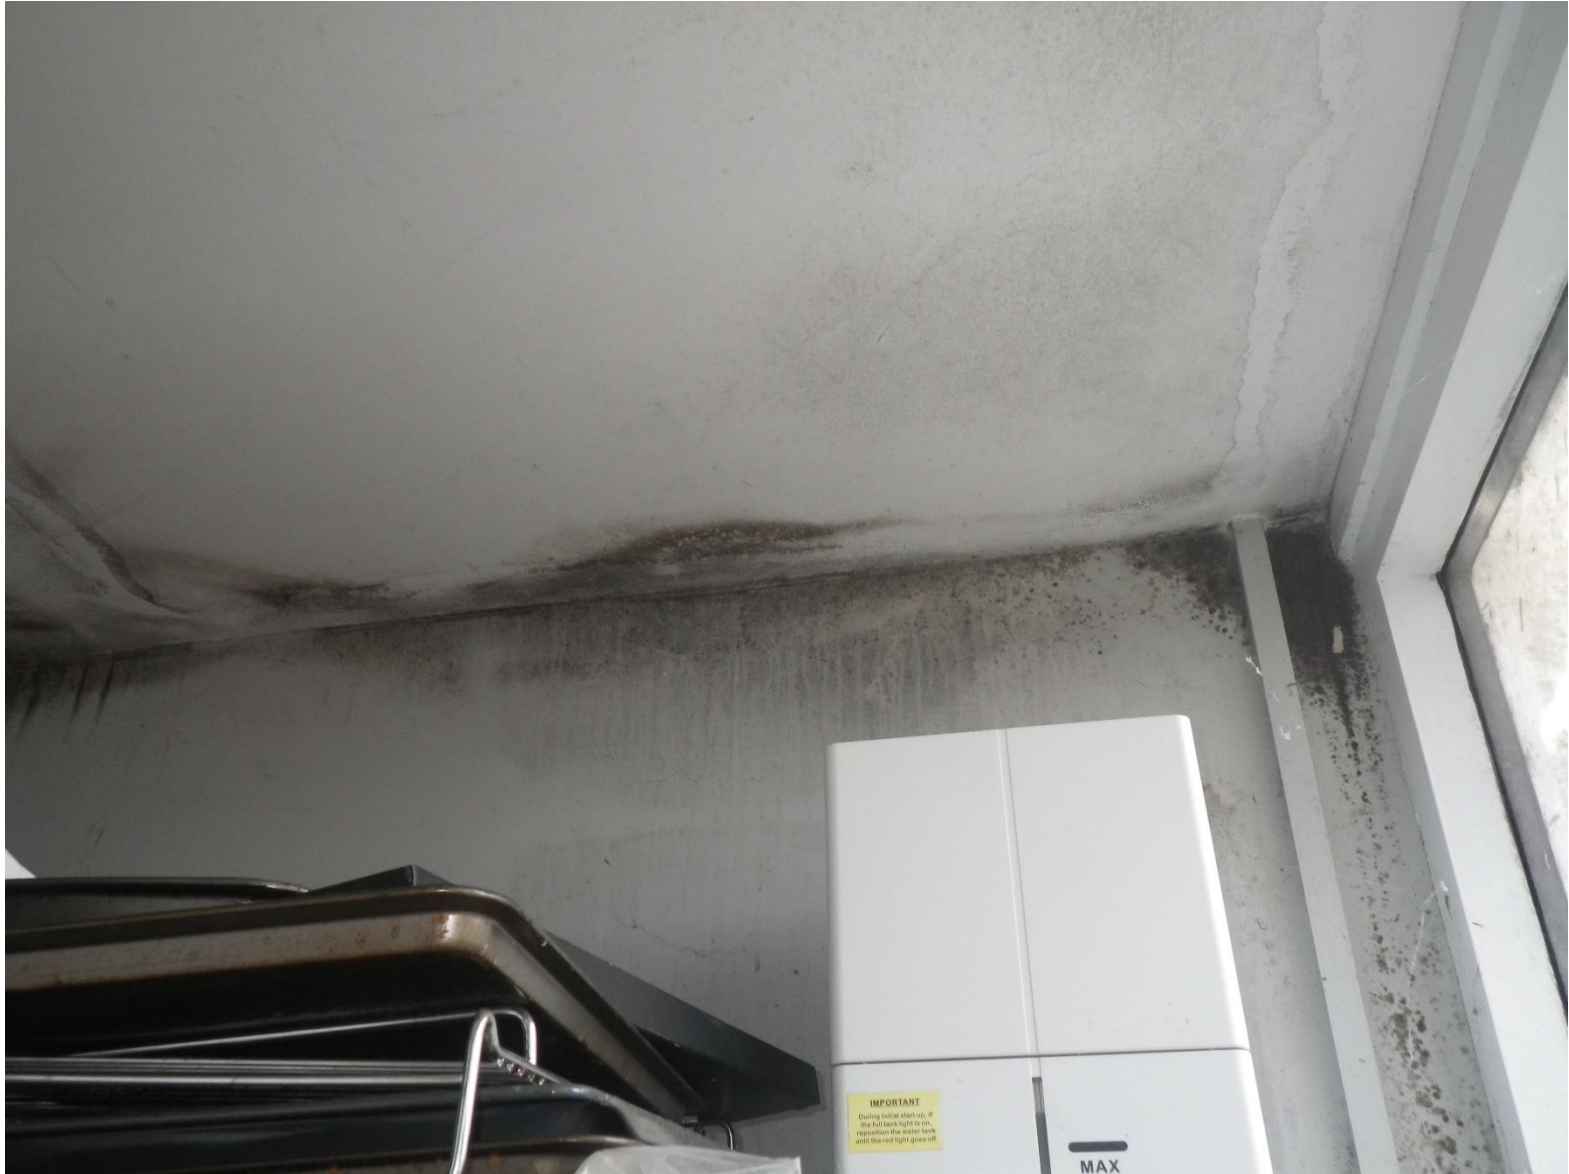
Walls appear to be in reasonable condition, with no sign of major failure. The exception would be the Utility Room, which has deteriorated since the date of the last inspection, with heavy condensation and decay noted. This Utility Room is to be demolished shortly and re-built.

***Heavy condensation to Utility Room***

Repair	Cat	Cost
Repairs included with planned refurbishment.	E	To be confirmed.

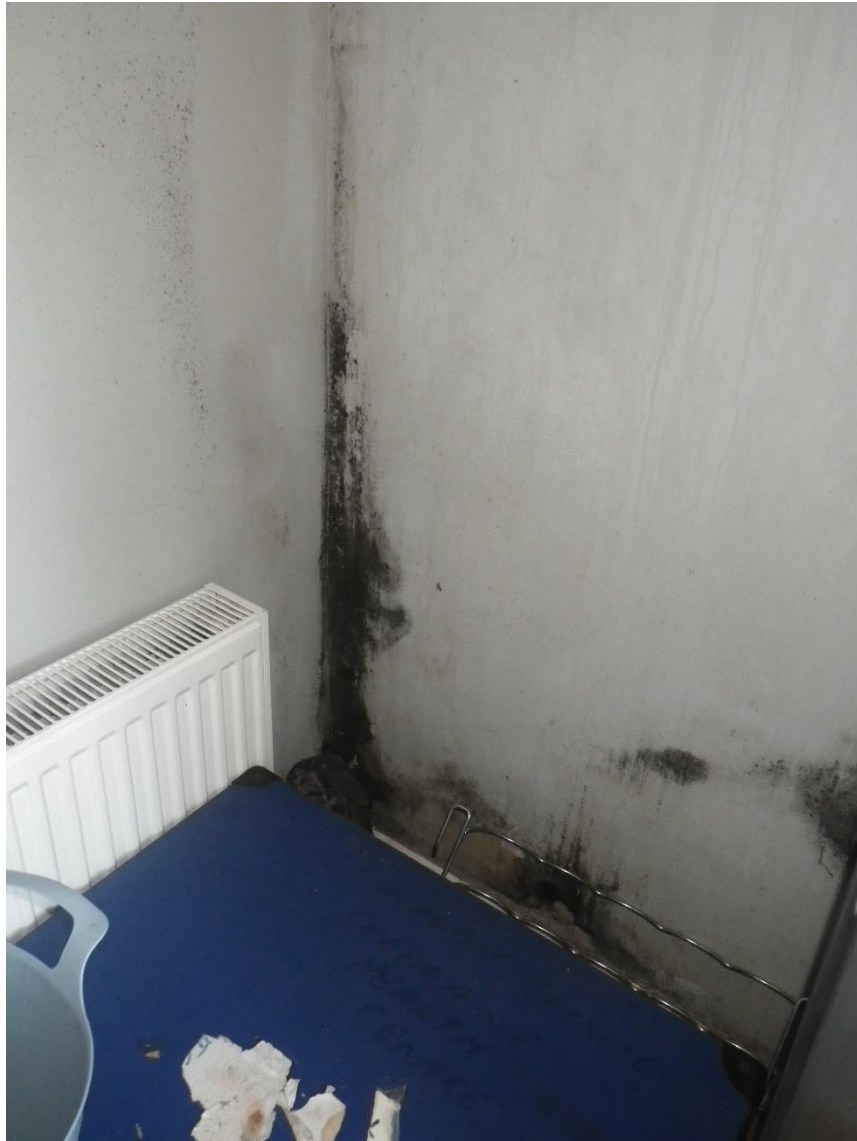
***Heavy condensation to Utility Room***

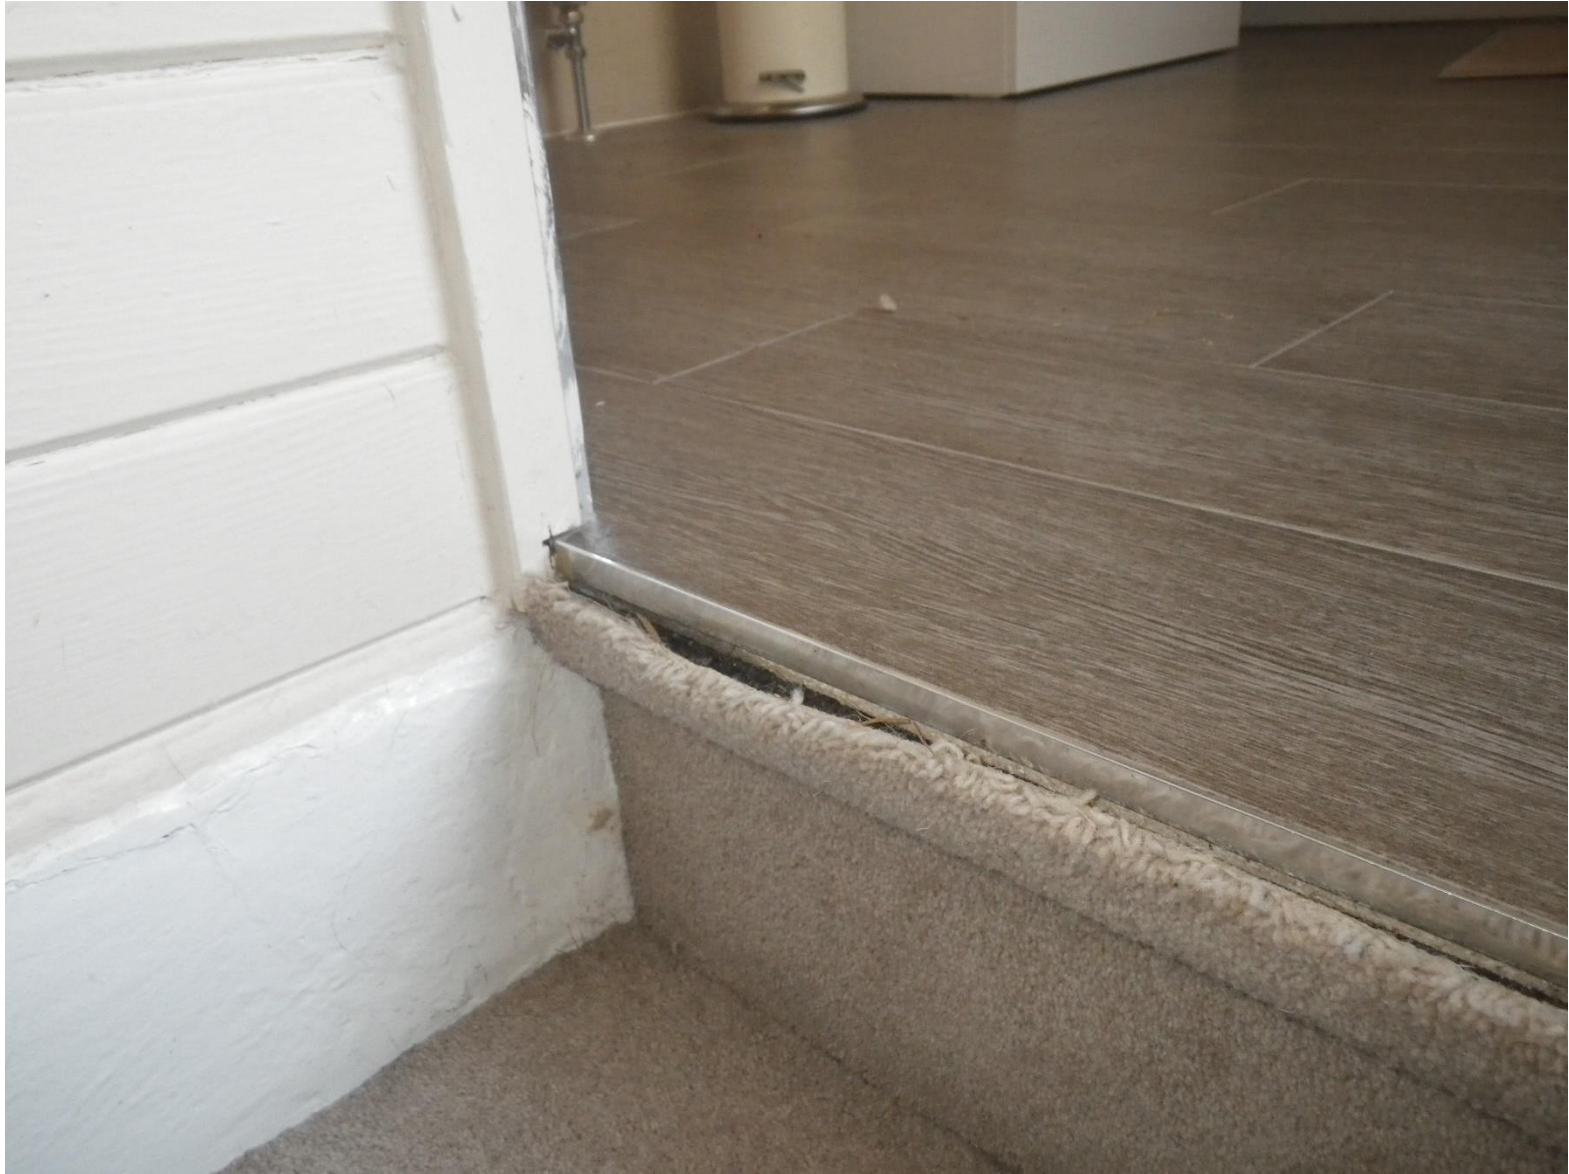
***Trip hazard to Bathroom door threshold***

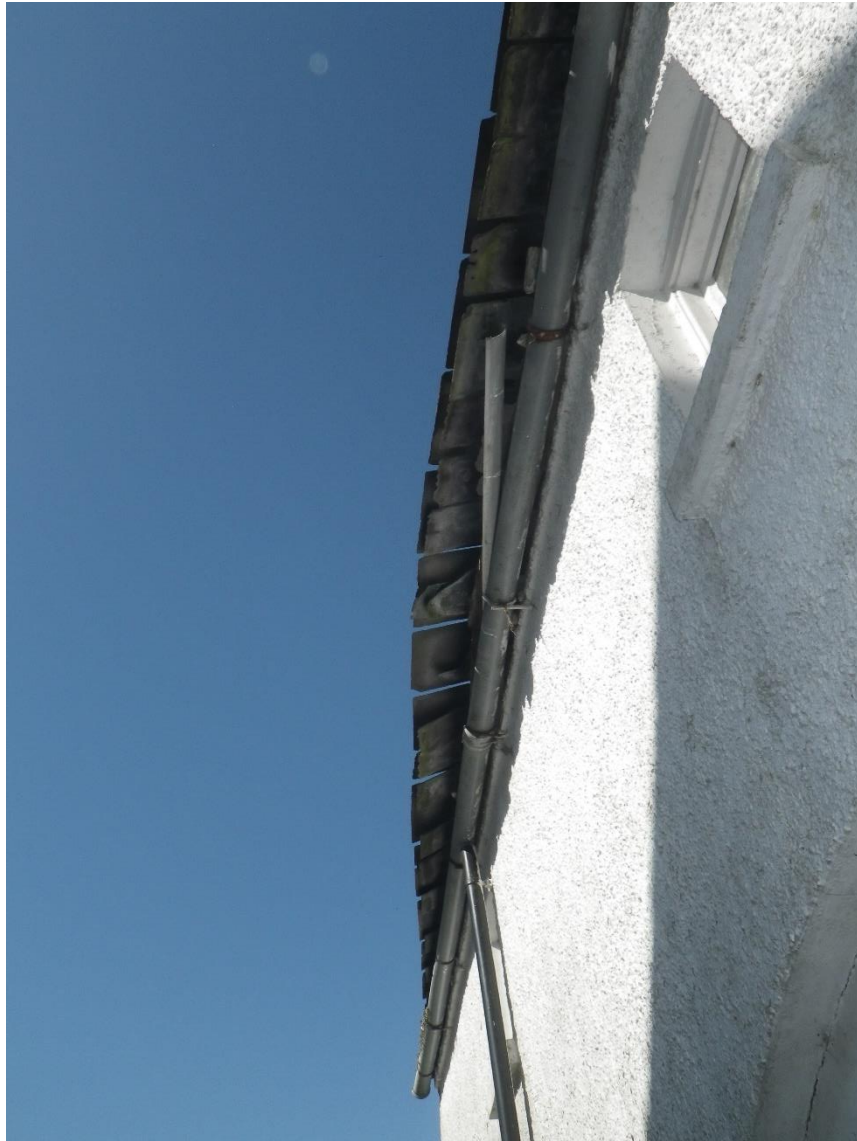
***Risk of falling slates outbuilding roof***
