**St John the Evangelist  
Ballynure & Ballyeaston  
Antrim  
Connor**

**Quinquennial Inspection Report**

April 2025

**McCOLLUM CONSERVATION**

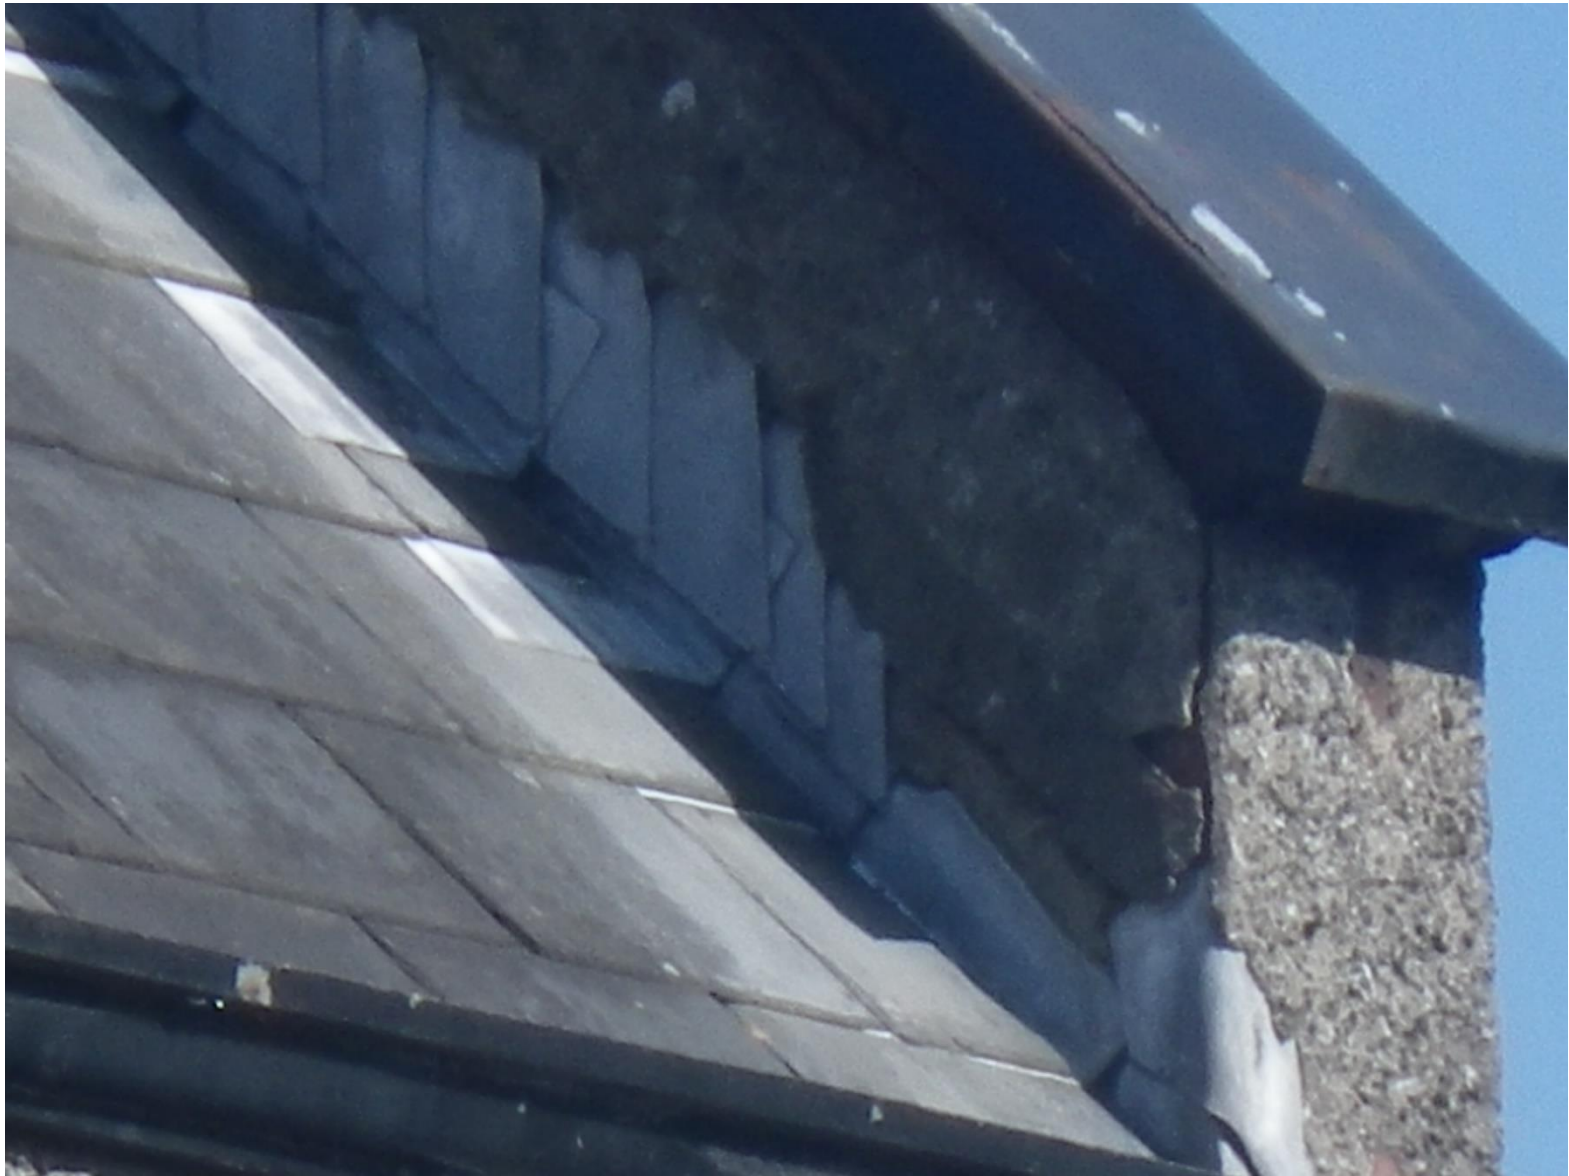
Roof slating remains in serviceable condition, although it should be ensured that, where repaired, new slates are of equal size, thickness and type. There is a small amount of lead flashing missing to the Chancel roof upstand and this should be renewed. Ridge tiles appear to have been partially renewed since the date of the last inspection.

*Failing lead detail at Chancel roof abutment*

Repair	Cat	Cost
Make good Chancel lead flashing.	B	£700

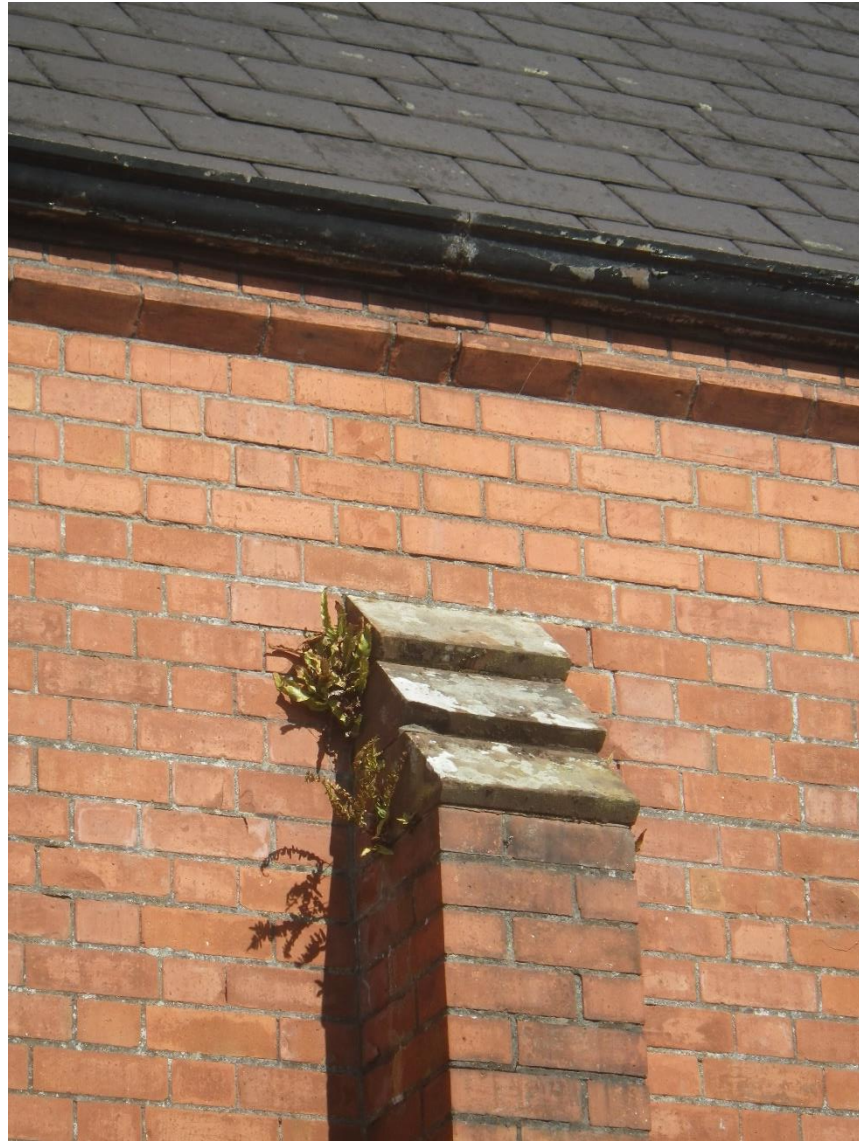
Walls appear to be in serviceable condition and the brickwork and pointing is holding. The vegetation noted in the previous inspection has not increased since then, but is an indication of dampness. Following the repairs to the gutter, this vegetation should be sprayed.

*Vegetation growing to south wall pier*

Repair	Cat	Cost
Spray and remove vegetation to south wall.	B	£200

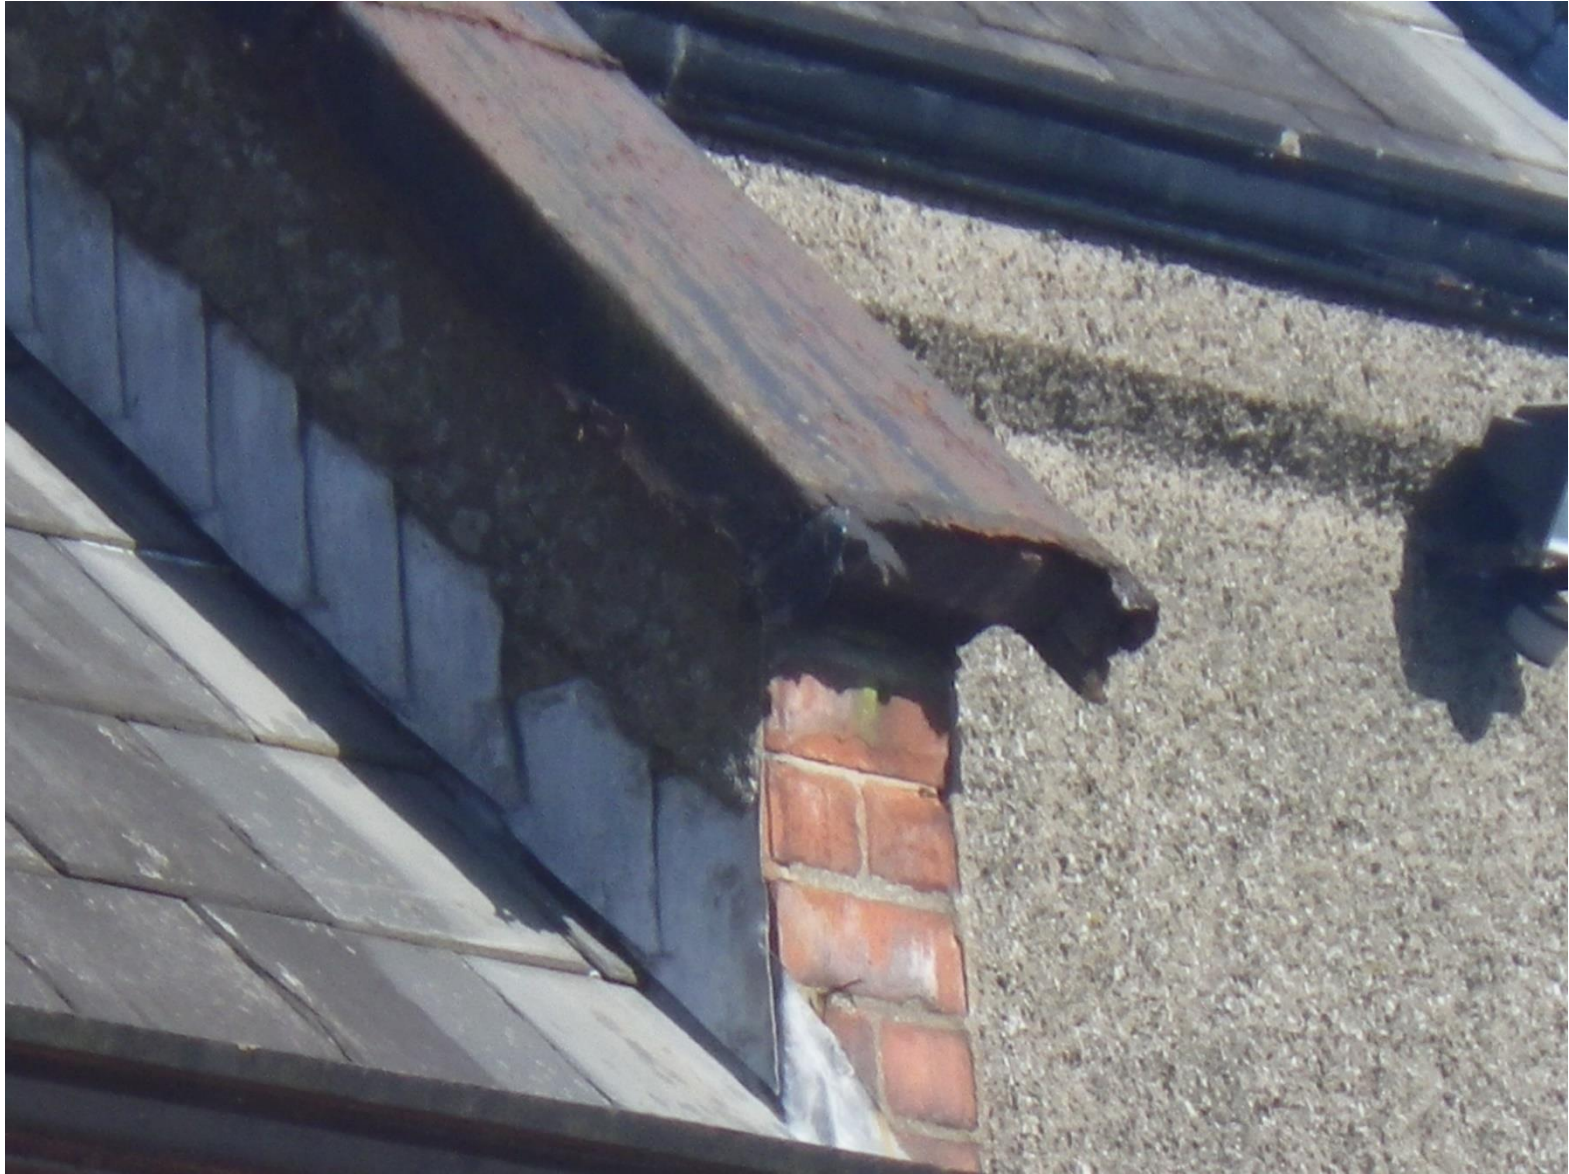
The metalwork covering the verges has now reached the end of its life, particularly on the Chancel, and over the next reporting period, sections will most likely require to be renewed. The render panel below the verge stones on the Chancel appears to be cracked and loose and will require to be renewed in this reporting period.

***Failing metal covers to verges***

Repair	Cat	Cost
Re-render Chancel verge.	D	£3,000
Renew sections of metal verge liner.	C	£5,000

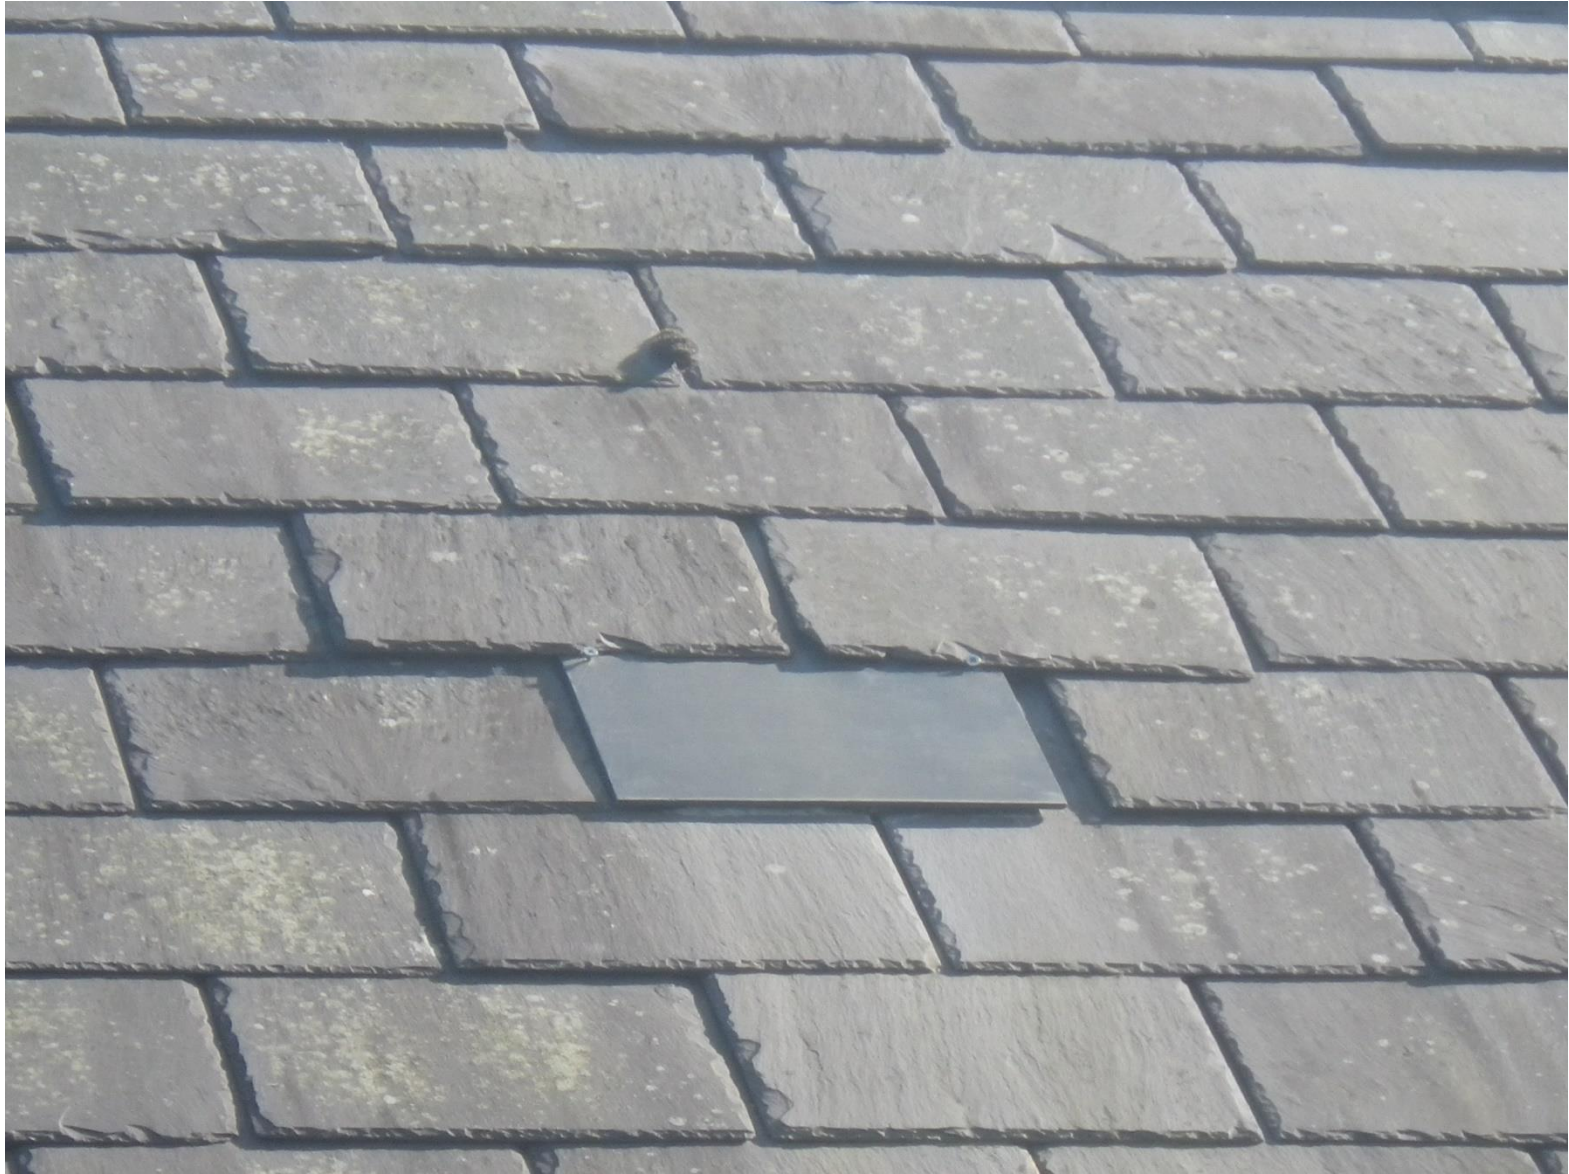
*Poor replacement slate*

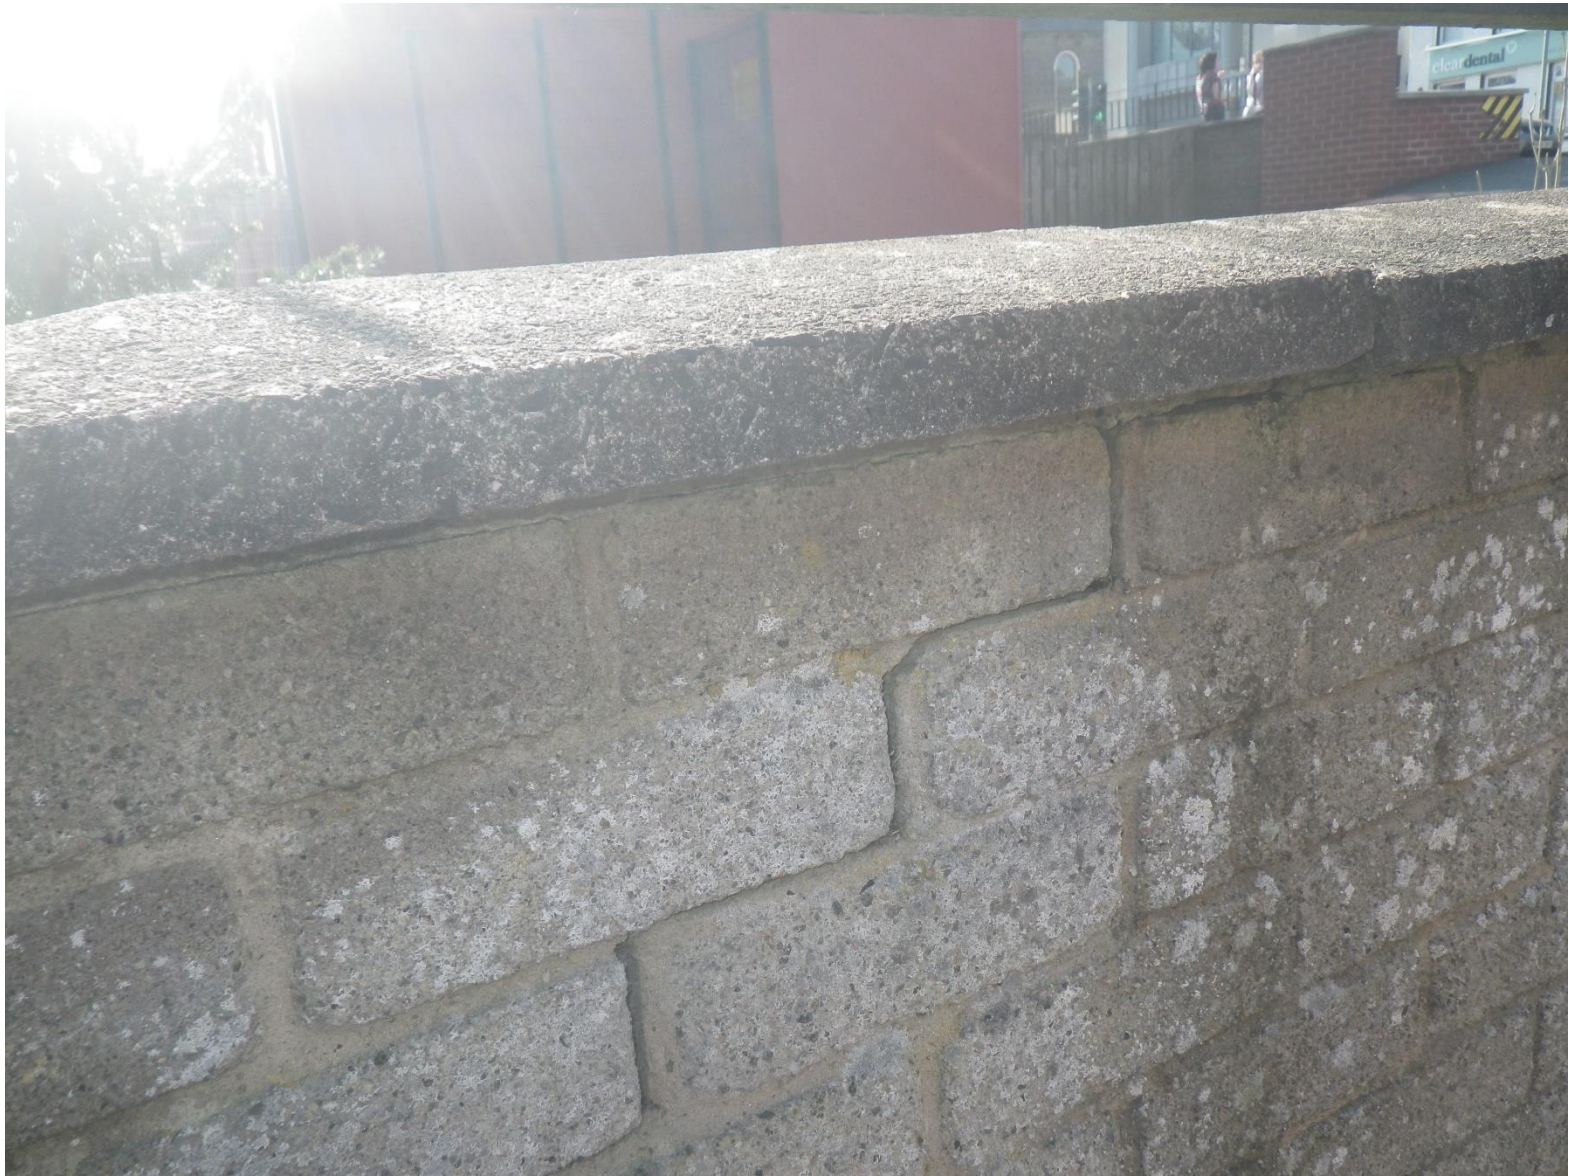
The site is a little untidy on its north side where debris is accumulating around a fire escape and this should be tidied up. The railings would benefit from some decoration and a section of wall is loose and should be re-bedded.

***Loose brickwork to boundary wall***

Repair	Cat	Cost
Re-bed loose section of wall and redecorate railings.	C	£2,000
Clear debris from alleyway around fire escape.	A	£ Nil

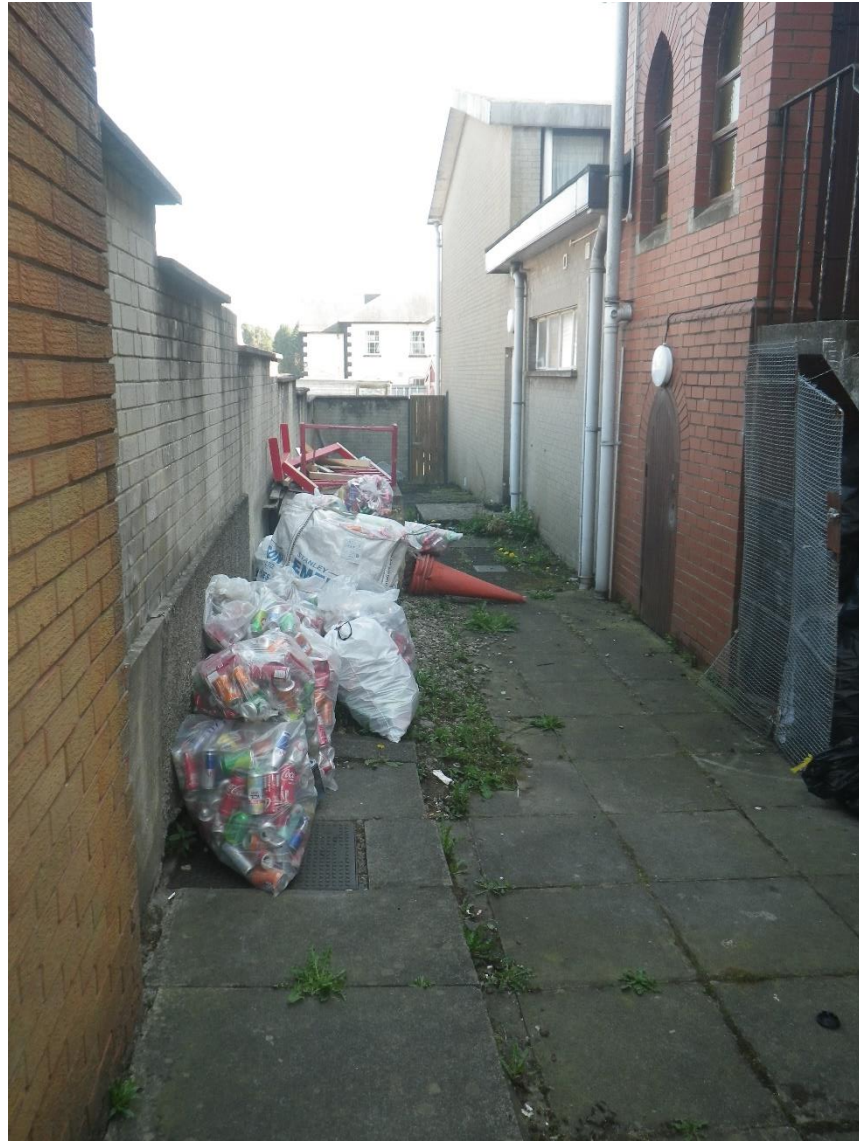
***Debris gathering at fire escape***

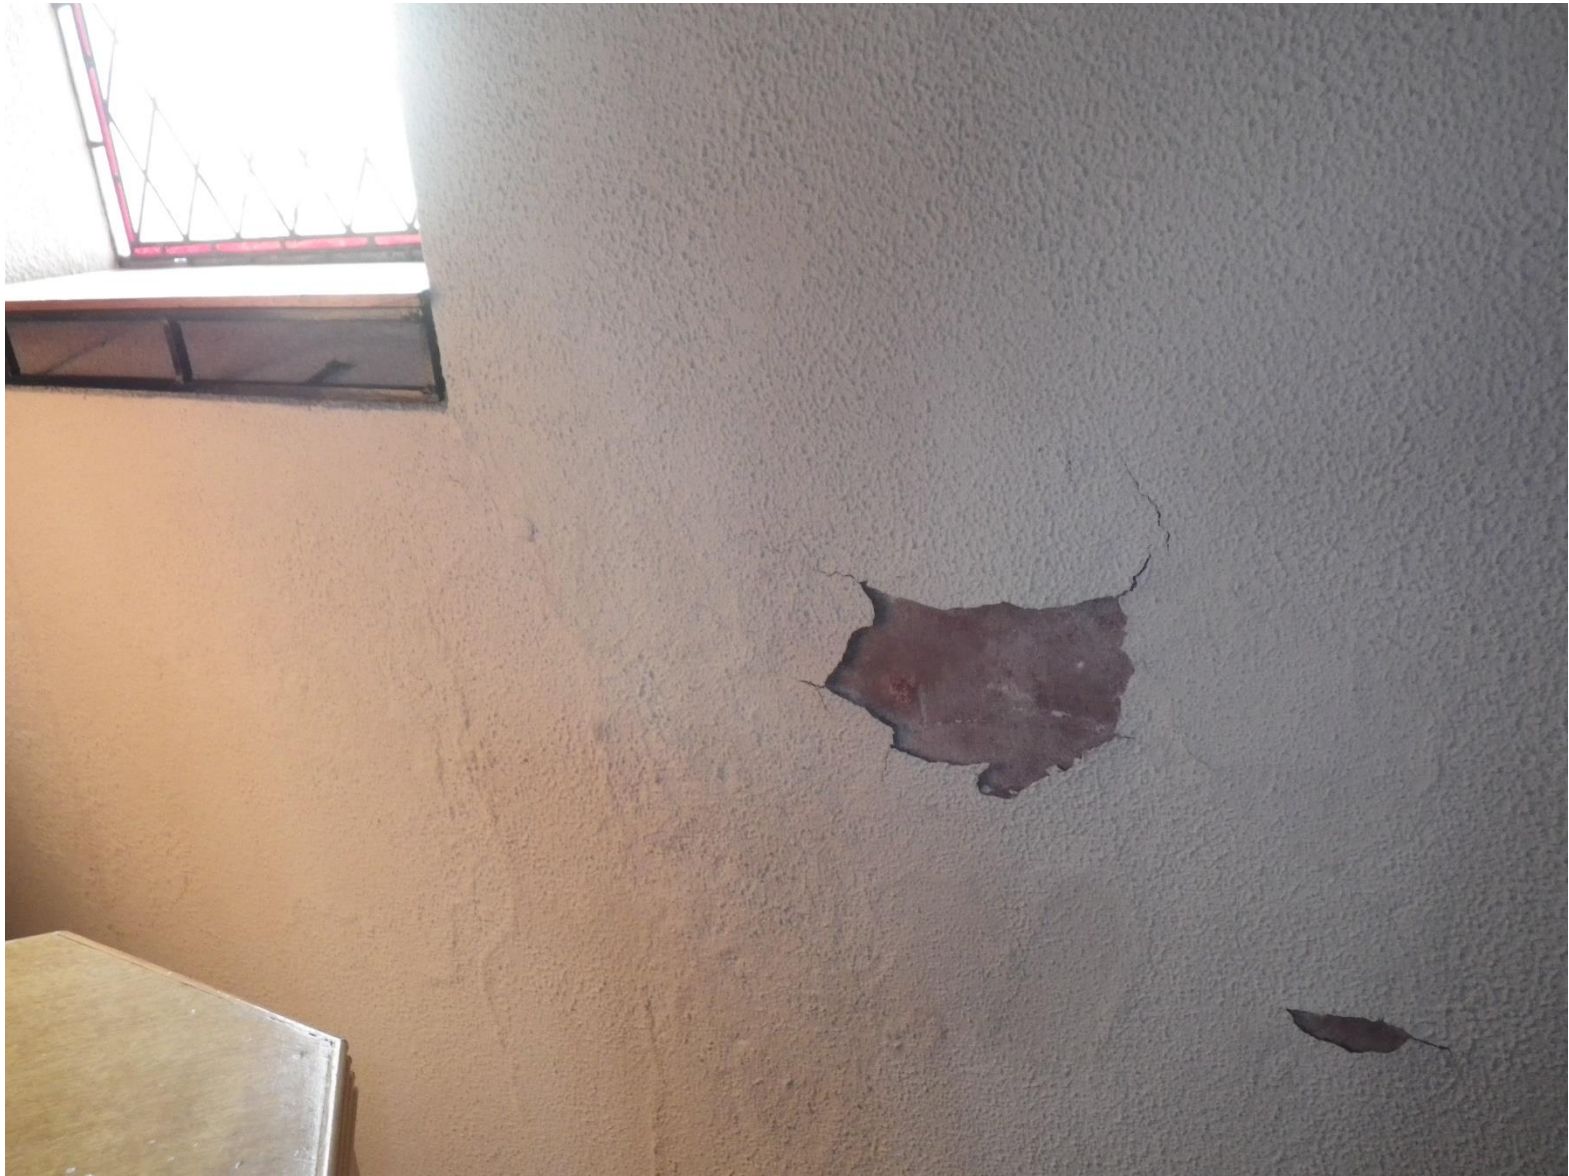
The walls appear to be structurally sound and are generally in good condition. The cracking within the Vestry has not increased since the date of the last inspection and could now be re-plastered. There remains some failing plaster along the south wall, and

this could be repaired (with external works to a downpipe arranged).

*Residual dampness to Nave wall*

Repair	Cat	Cost
Re-plaster cracked plaster within Vestry.	E	£600
Plaster repairs south wall.	E	£300

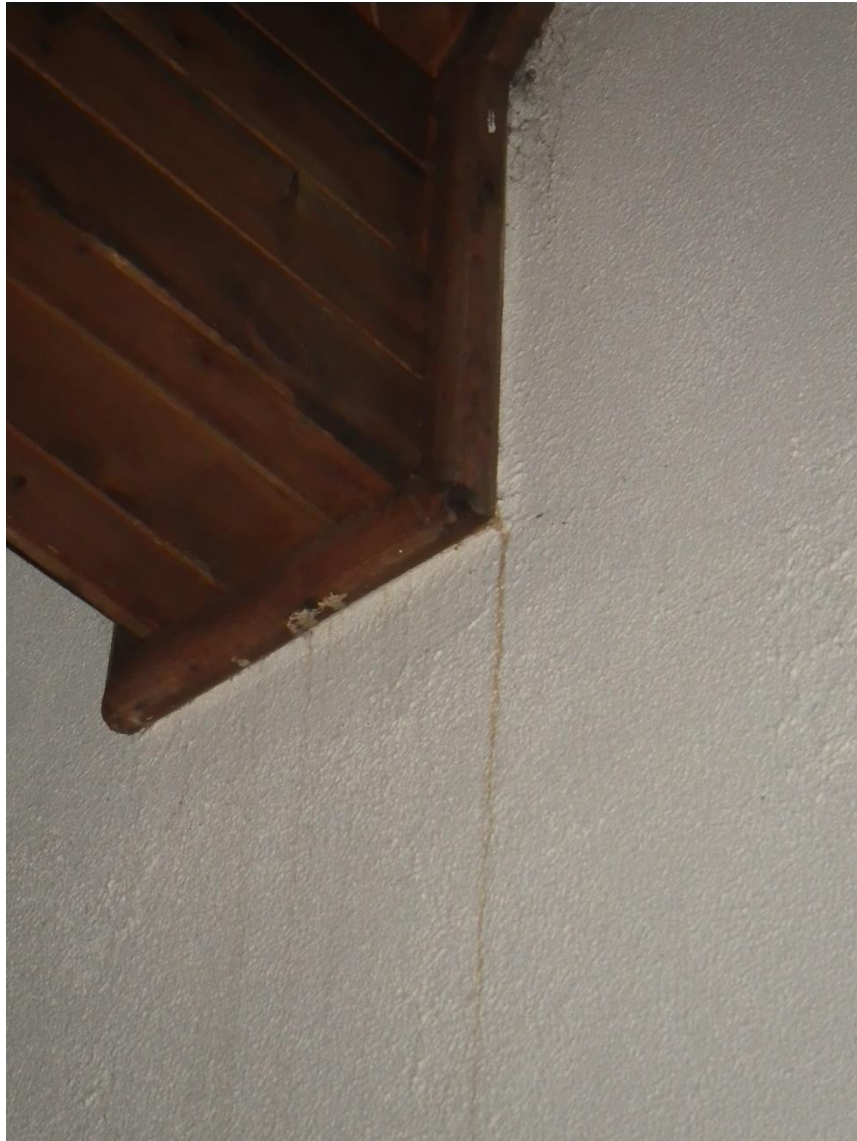
The hidden gutters above the side aisle could not be inspected, but there was some evidence of past leaks internally. For that reason, periodic access should be arranged to ensure the gutters remain clear and in good condition.

Ceilings appear to be in reasonable condition, but with a slight water mark to the north of the side aisle (below a hidden gutter).

***Evidence of slight water penetration to north Aisle roof gutters internally***
